GEOGRAPHICA

Vol. 6, 1970

DEVIATION OF THE SUNGEI MULIA

V. MAHESWARI*

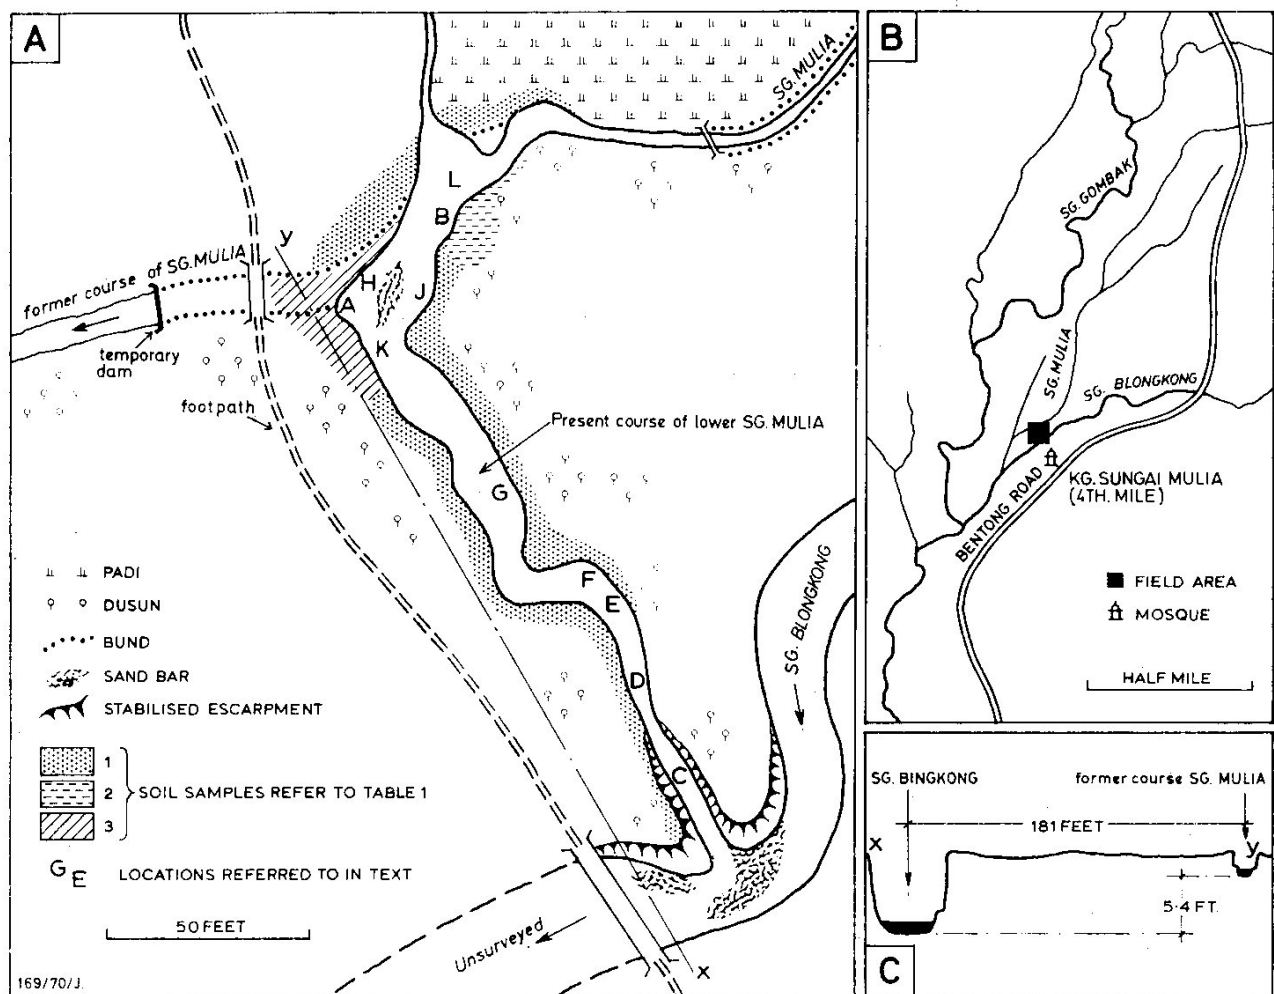
Fig. 1A: *Diversion of the Sungei Mulia.*

The deviation involved the breaching of the bund somewhere between A and B in Fig. 1A. On June 25th when the writer first saw the area, there was still vertical erosion and slumping giving rise to bare vertical banks from point C headwards (Fig. 1A). Within eleven days, from the new cut alone, 1810 cubic feet of dusun soil had been removed. Aided by surface and sub-surface seepage from the padi fields, padi land had also collapsed (Plate 1).

Though water depth did not decrease greatly (1.2 feet compared to a previous 1.4 feet) the width of the channel had on average more than doubled. At point H (Fig. 1A) widths of 11 and 12 feet, measured on June 27th and 2nd July respectively, showed a progressive widening which had not ceased even on July 21st. At the breach in the bund the width at the time of survey measured 30 feet compared to a previous 5.5 feet.

Again though water depth had not changed much, the stream had incised itself such that at the time of survey the average bankfull depth was 5.6 feet compared to a previous 2.7 feet. Bankfull depth increased downstream to a maximum of 8.3 feet at point C (Fig. 1A). This downgrading and collapse of bunds on either side extended till point 'J'; the knickpoint had travelled 380 feet in 23 days.

This incision produced a marked steepening of the Mulia's profile. The former gradient calculated to be 1:148 using exposed bed and bund heights, had increased to 1:49 in the new channel. The regradation has left the old channel and parit mentioned earlier as hanging valleys, pro-

Two streams flowing within a short distance of each other with the bed and water surface of one much higher than the other create a potentially unstable situation. Had the hydrologic conditions in the area been uncontrolled and the Mulia not been bunded or canalised, the deviation would have occurred much earlier.

On July 6th the parit contributed 18% of the total flow of the Mulia (Table 3). If its discharge had been increased for some reason, it could have produced a significant deflection of the main stream of water, causing it to erode the left bank of the Mulia. Fig. 1A shows the bunds and channels to have been slightly sinuous at this stretch. Thus a certain amount of friction against the left bank would have been present, and even a slight deflection of the main stream might have been sufficient to cause the current to erode the sand at B instead of the clay. This would have caused not only soil erosion but also a greater quantity of water to flow down the overflow channel, creating two possibilities.

The bed-bank difference was greatest at C and D (Fig. 1A) where the slopes were already graded and stabilised. The increased flow down the overflow channel could have caused the knick-point to retreat rapidly upstream and thus divert

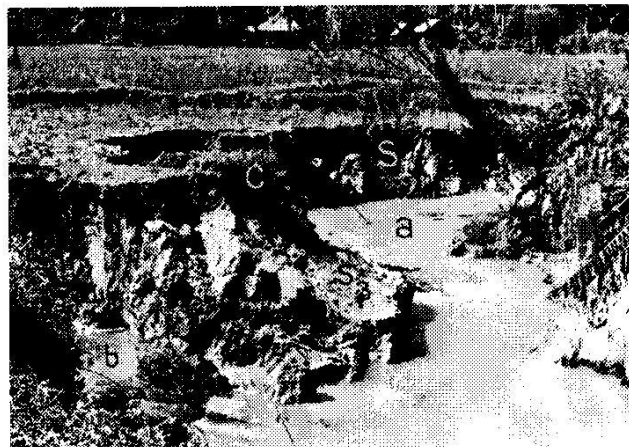
Plate I: *Erosion of Padi Land*

Note the differential erosion of soil samples I and 3 (S I and S 3 respectively), which correspond to those shown on Table 2 and Map 3; the remaining portion of the bund (c) and the padi dying in the sawah. The Mulia and the kampong taliayer are annotated 'a' and 'b' respectively.

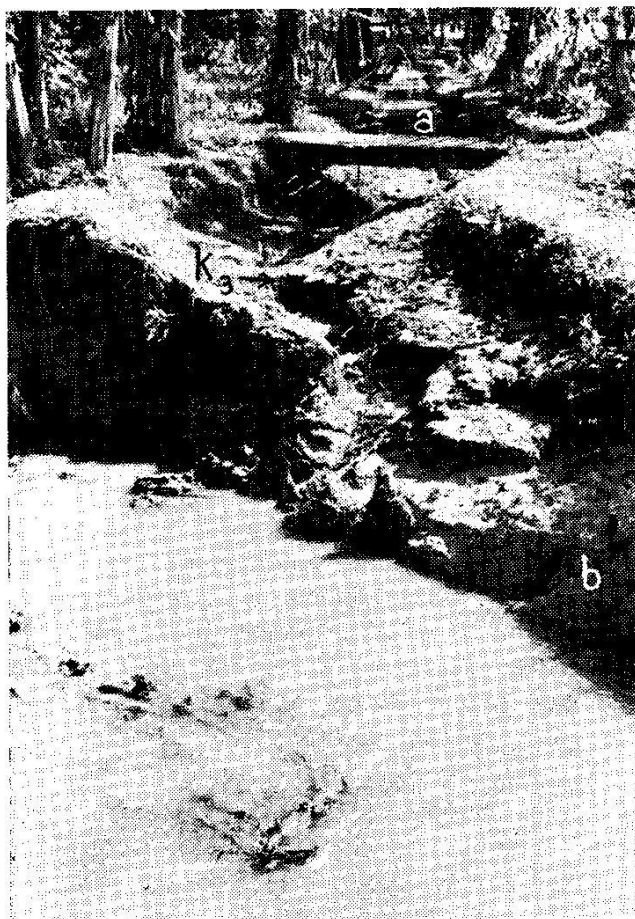
Plate 2: *The Old Lower Mulia*

ducing marked knick-points in their respective profiles, and a reversal of flow in the former Mulia making it a tributary of the new channel. This was checked with a temporary dam (Fig. 1A and Plate 2), delaying the process of undercutting and slumping.

A downcutting of the bed is discernible and the knick-point marking the head of the regradation corresponds to K 3 on Map 3. Note the temporary dam across the Mulia (a); and the holes in the clay profile (b), through which there is a sub-surface seepage of water.
