**An assessment of the potential for *in situ* preservation of buried organic
archaeological remains at Sutton Common, South Yorkshire**

being a Thesis submitted for the Degree of Doctor of Philosophy

James Leslie Cheetham BSc MSc

April 2004

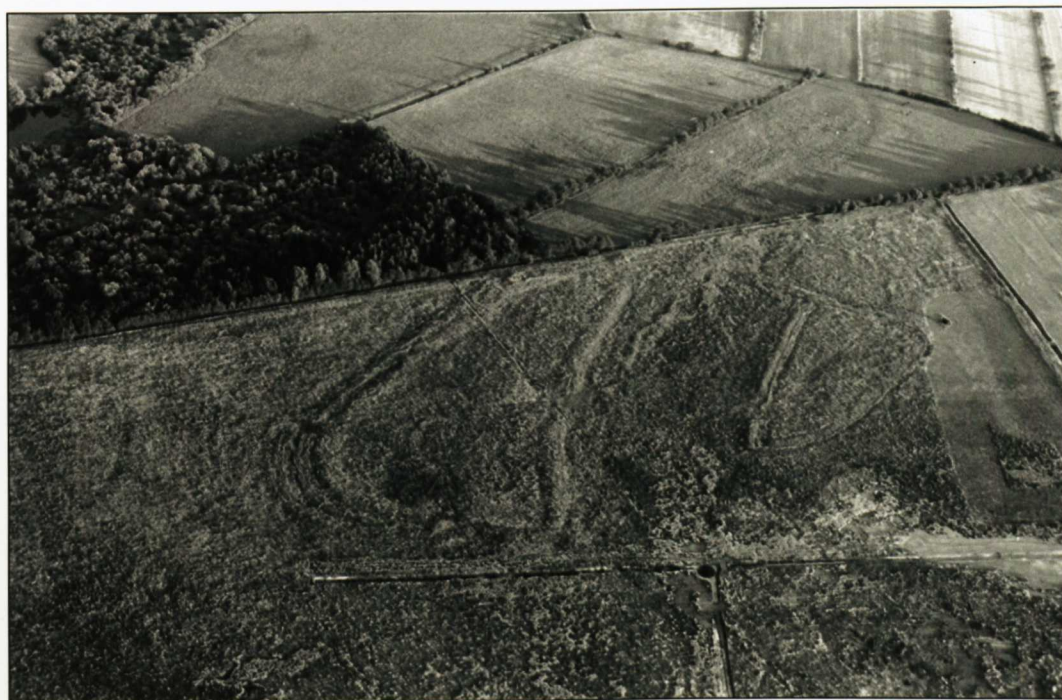
Figure 2.6 Aerial photograph of the Sutton Common enclosures viewed from the north taken in 1976 prior to them being damaged. (DNR877 SE5612/8/36 - 7.7.1976) NMRC © Crown Copyright.

are formed by a double ditch with three banks (Head *et al.*, 1997). There are a number of breaks within the banks and ditches suggesting the presence of one or more entrances to the enclosure. Enclosure B is smaller than A, being 150 m in length by 80 m in width and is more triangular in shape. Figure 2.6 is an aerial photograph taken prior to Enclosure A being bulldozed and clearly shows the upstanding earthworks of both enclosures and the unimproved nature of the vegetation. Figure 2.7 shows a similar aerial photograph taken in 1979 following Enclosure A being ploughed for the first time. The location of the enclosure can clearly be seen in the soil marks left by the action of the plough, as can the banks and ditches. Also, the damage to the south eastern edge of Enclosure B can be seen as a lighter coloured area. Although the area around Enclosure B had not been ploughed at the time this photograph was taken, it soon was, leading to further damage to its periphery.

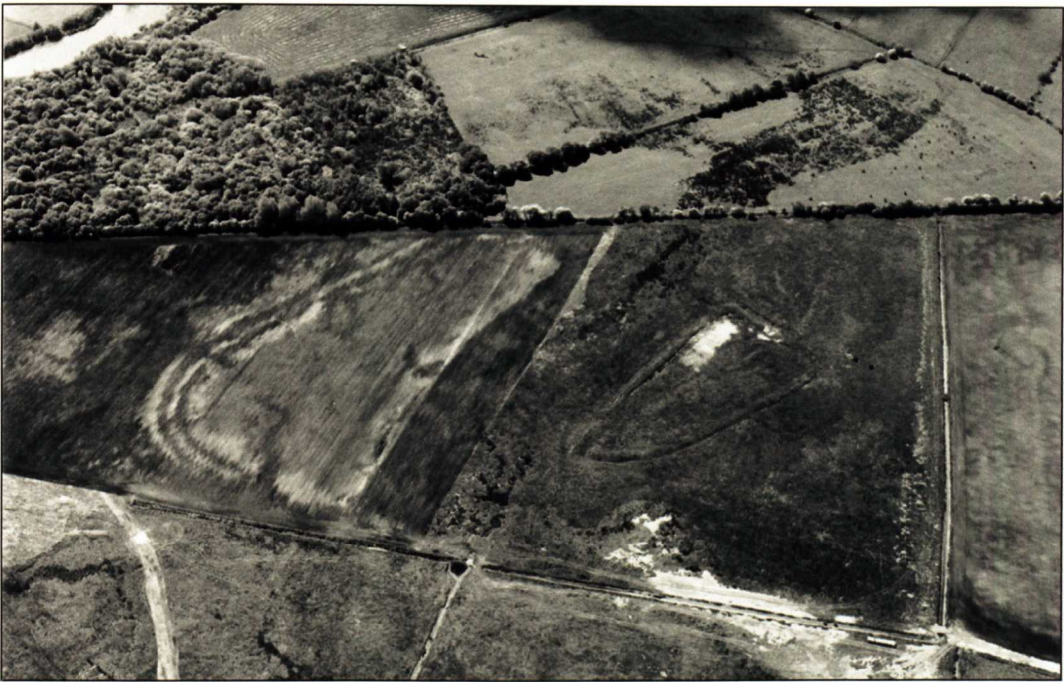
Figure 2.7 Aerial photograph of the Sutton Common enclosures viewed from the north taken in 1979 following Enclosure A being ploughed for the first time. (DNR1586 SE5612/26/7 - 13.9.1979) NMRC © Crown Copyright.

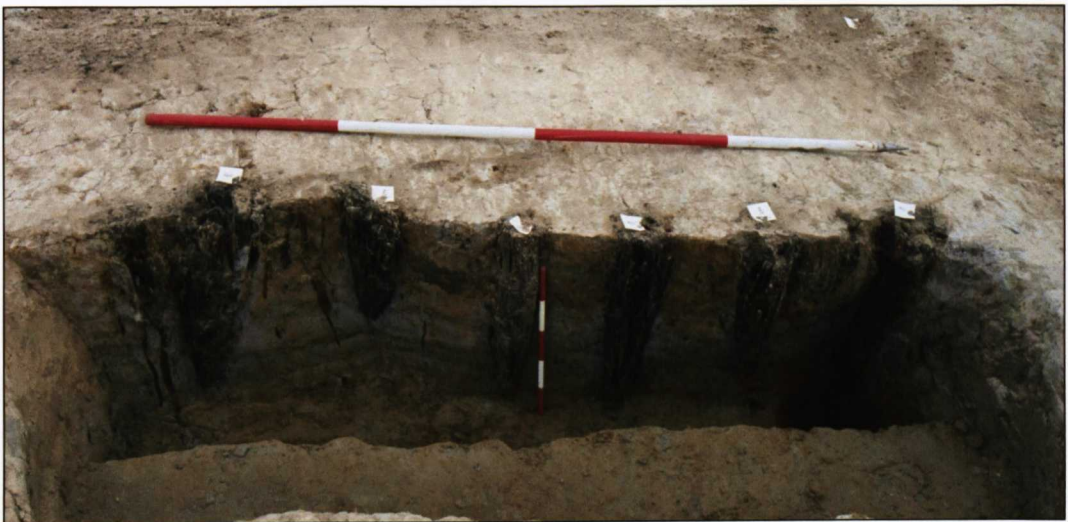
Figure 2.9 Exposed section of the Enclosure A palisade structure at Sutton Common. 2003 excavations. Refer to Figure 2.8 for location.

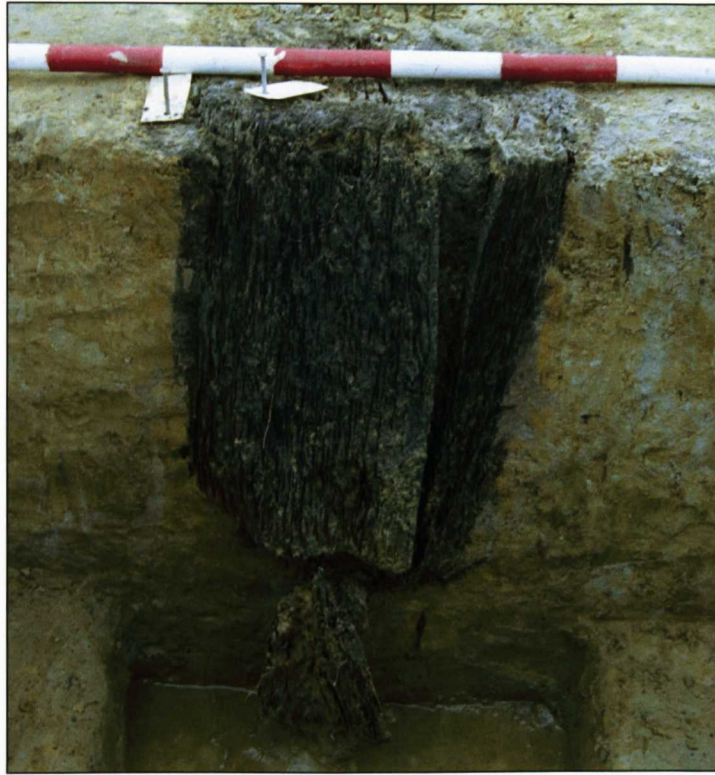
Figure 2.10 Exposed section of flat-bottomed post from internal structure of Enclosure A. 2002 excavations. Refer to Figure 2.8 for location.

The types of organic archaeological remains that have been identified during excavations on Sutton Common over recent years consist mainly of the worked ends of posts or stakes. The stakes were sharpened to a pencil point, (for the most part) for the construction of a palisade, or a low earth bank bordering the entire enclosure, and also delimiting the causeway crossing the palaeochannel (refer to Figure 2.9). Large posts shaped to have flattened bases have been identified at both the eastern and western entrances of Enclosure A and smaller, similarly constructed posts, form structural elements of some of the internal features (refer to Figures 2.10 and 2.11).

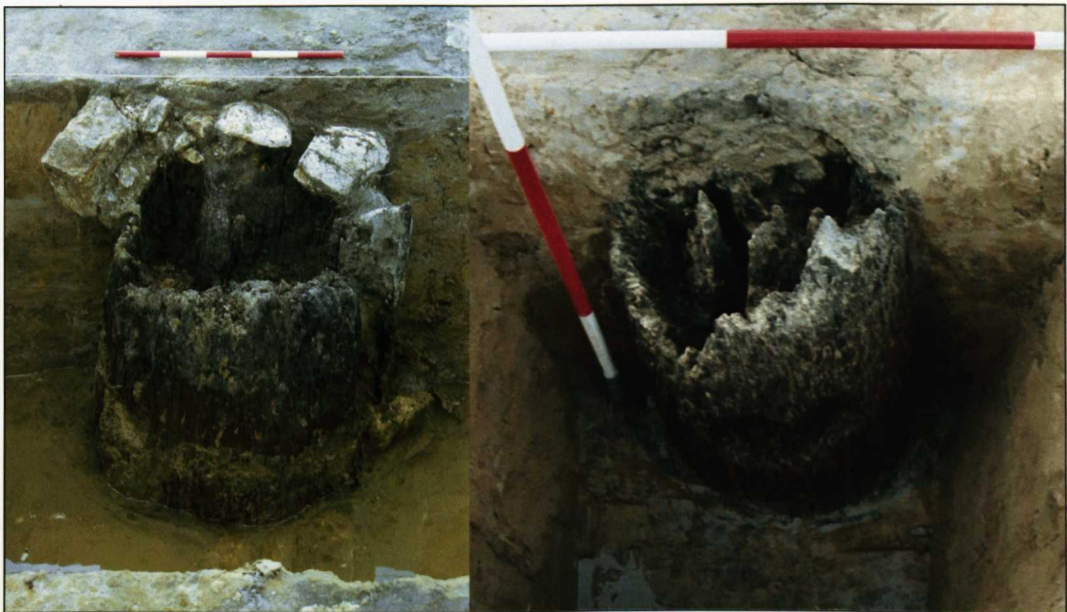
Figure 2.11 Exposed section of large flat-bottomed posts associated with Enclosure A entrances. 2002 and 2003 excavations respectively. Refer to Figure 2.8 for location.

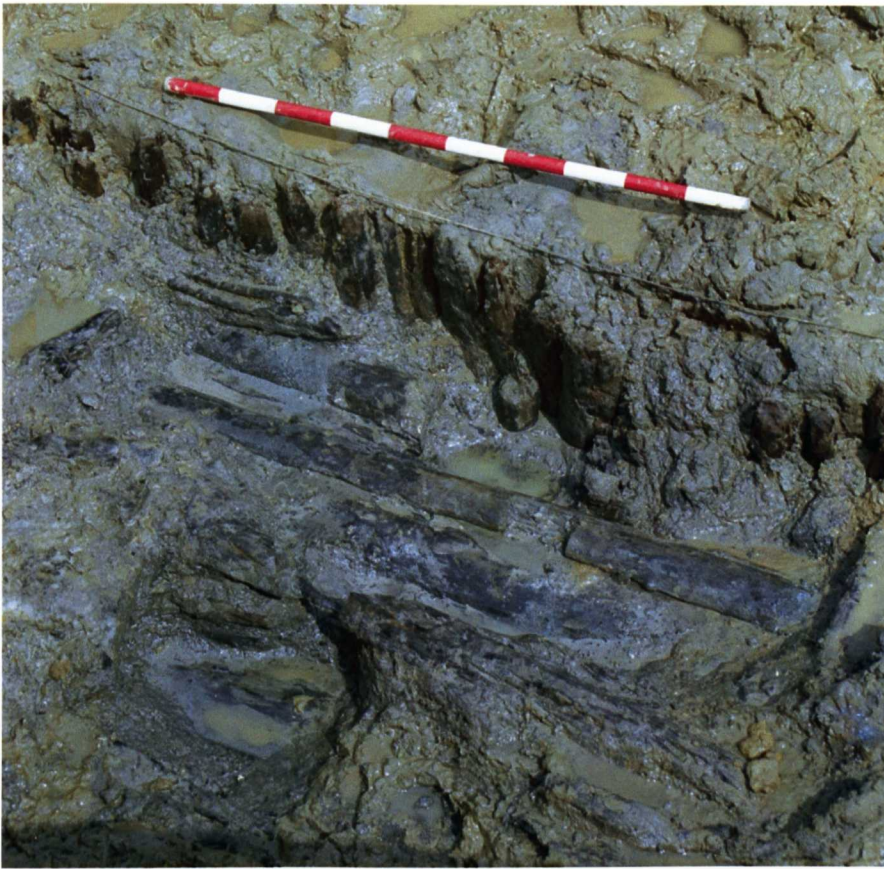
Figure 2.12 Part of the excavated 'well' within Enclosure A exhibiting very good preservation of archaeological wood. 2002 excavations. Refer to Figure 2.8 for location.

incorporated into the fills of ditches, especially along the eastern edge of Enclosure A, show good preservation, although desiccation within these contexts is evident. The best quality of preservation so far identified relates to one specific feature located in the southern part of the enclosure, this feature having been interpreted as a possible well. The structure itself consists of vertical stakes with the remnants of woven rods between them. In the base were a number of roundwood beams laid flat (refer to Figure 2.12). The reason for the exceptional quality of preservation in this location is its depth, with it existing below the level of the water table.

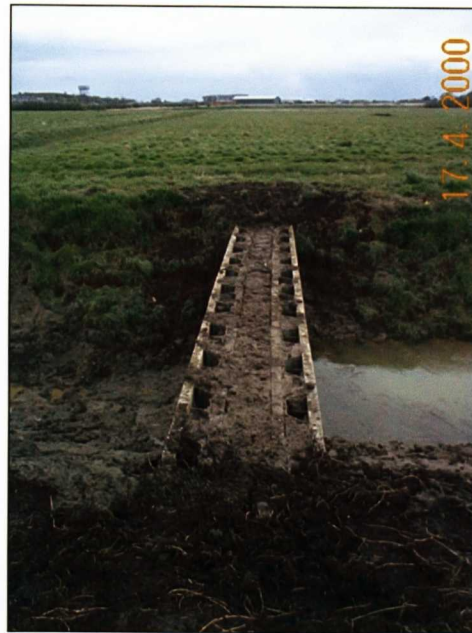
Figure 2.15 The dam installed within the drainage ditch running to the north of the archaeological enclosures. The dams are approximately 0.5 m in width.

illustrated in Figure 2.14, whereby the incoming pipe rises up into a concrete manhole. The level of the water is adjusted by raising or lowering the level of the inflow pipe. In addition, dams were placed in two locations on the site to restrict the loss of water from drainage ditches, the northern one of which is shown in Figure 2.15. Further proposals include the construction of a bund to prevent subsurface flow out of the southern end of the palaeochannel, although the exact location of this is yet to be decided.

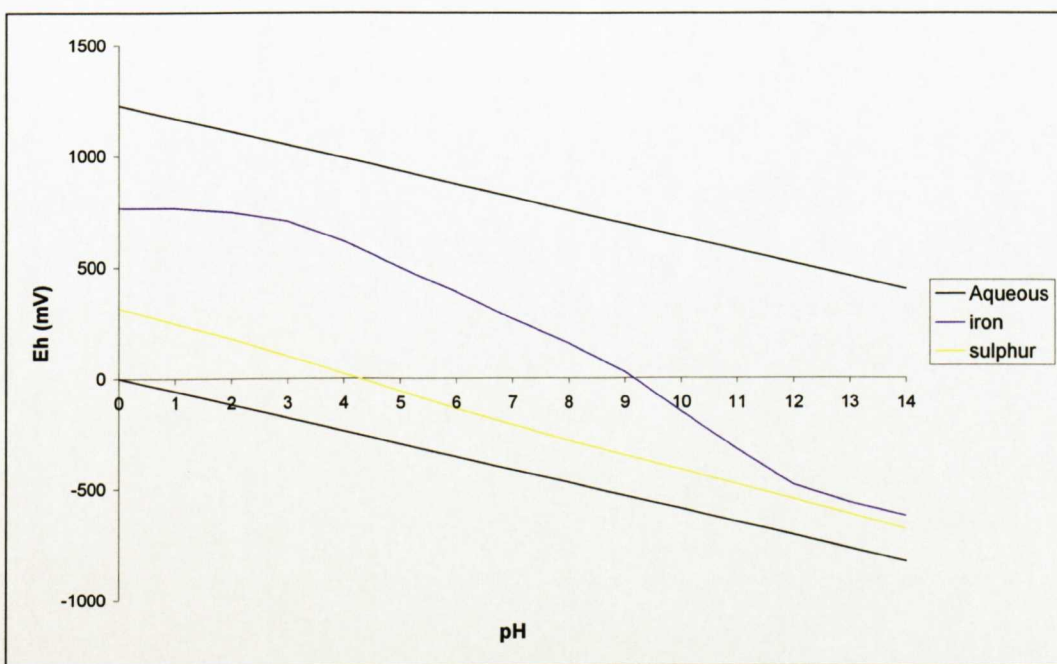
Figure 3.13 An Eh / pH diagram showing aqueous, sulphur and iron boundaries.

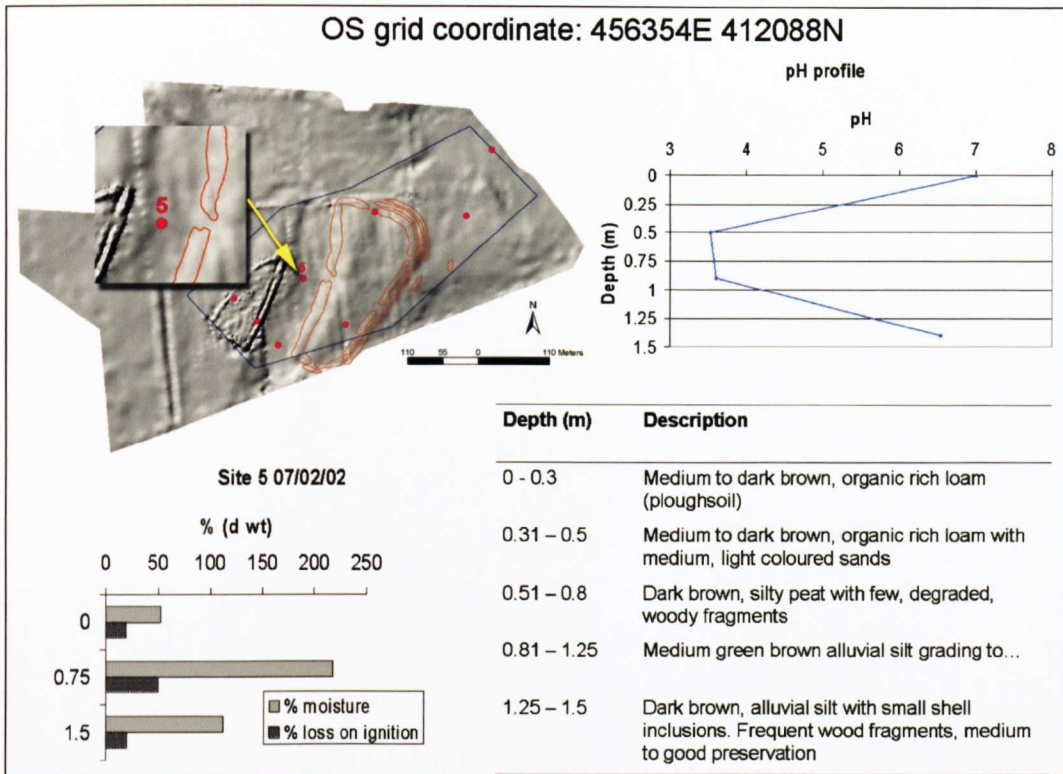
Figure 4.5 Integrated graphic showing location of Site 5, pH profile to a depth of 1.5 m, soil stratigraphy, soil moisture content and LOI values.

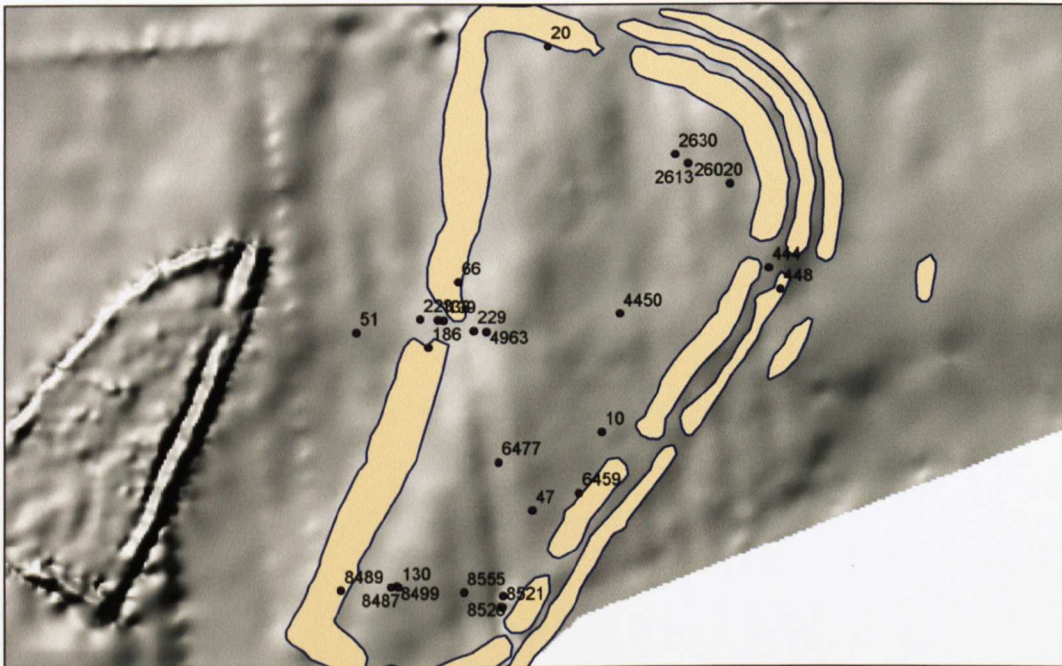
Figure 5.42 Sutton Common, Hillshaded DEM showing the location and context numbers of excavated pieces of archaeological wood. The outline of the former banks of enclosure A are also depicted.

Through studying the excavation archives, the location of pieces of archaeological wood has been identified and recorded along with the height range, in m O.D. at which it exists, i.e. its top and base heights. Once entered into an ArcGIS geodatabase, this information was manipulated within the GIS environment and compared to models created from the hydrological monitoring data. Figure 5.42, shows the locations of the pieces of wood along with their context numbers (refer to Appendix 6).

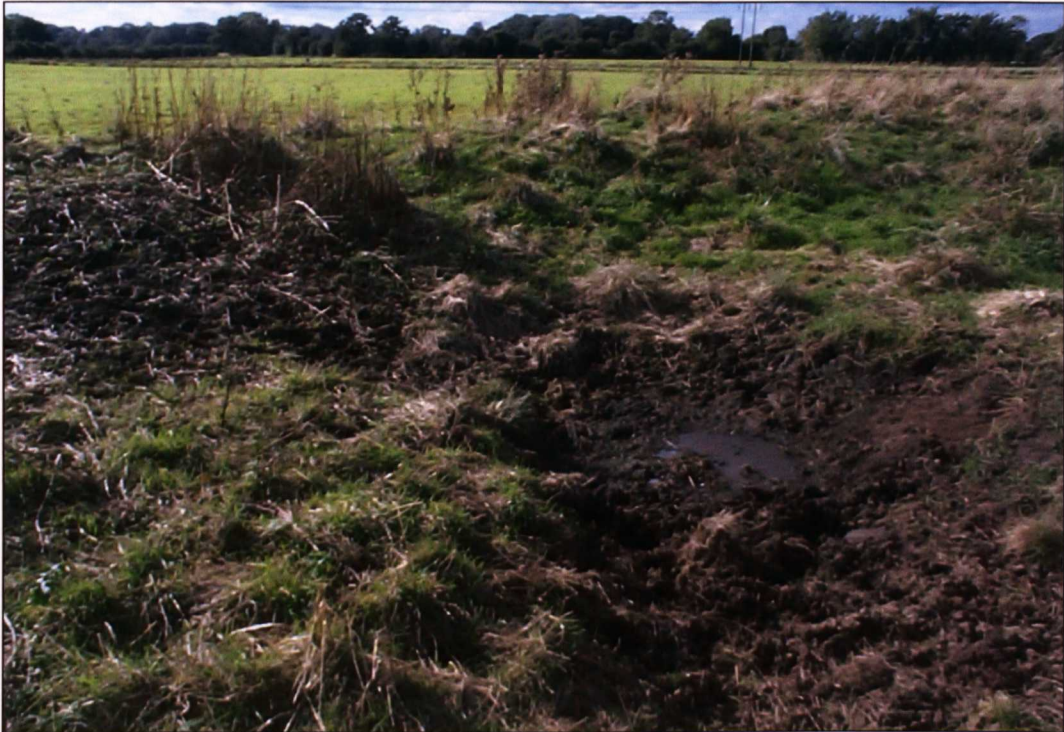
Figure 7.6 Location of cattle scrape from which a soil sample was obtained. Facing southwest located at the southern terminus of the internal ditch of Enclosure B.

trough, this being a concentrated area of activity, and a sample from within a ‘scrape’ within the internal ditch of Enclosure B, Figure 7.6. This location was chosen as the feature is known to contain well-preserved archaeological wood and an assessment of the potential impact of the camping behaviour upon this resource is desirable.
