THE TOOL:WORKPIECE INTERACTION WHEN MACHINING WELDED  
HARDFACING USING PCBN TOOLS

being a Thesis submitted for the Degree of  
DOCTOR OF PHILOSOPHY

XUEJUN REN, BSc MSc

May 2000

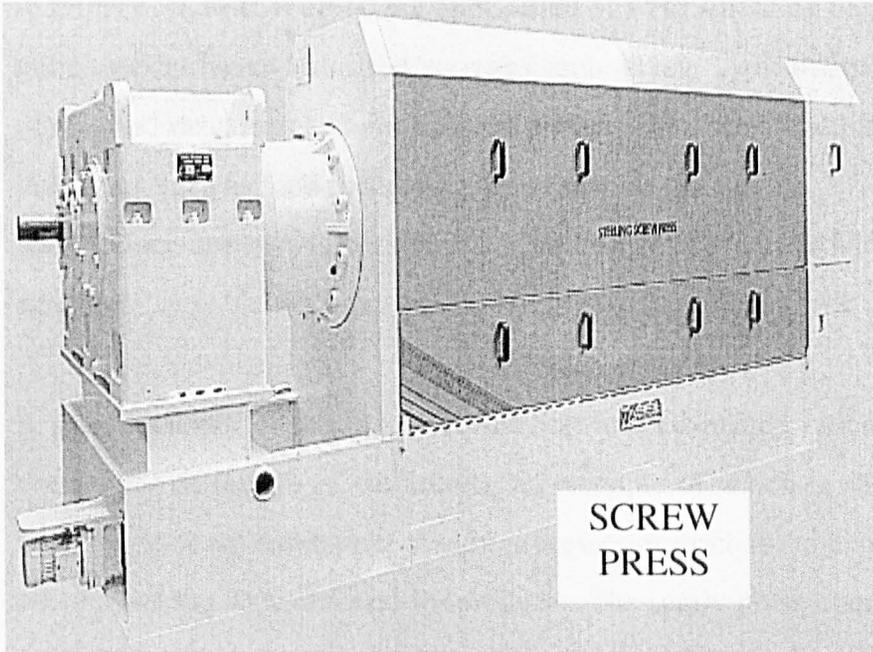
SCREW  
PRESS

A good example of the use of hardfacing in food-related industry is in the screw presses for extraction of edible oils, an example of which is shown in Figure 1.1. Screw presses are commonly used in processes of mechanical extraction of vegetable oil or breaking down animal by-products. The screw press operates under extreme conditions where abrasion on the vital components is a predominant problem. This is mainly caused by the passage of abrasive material attached to the oil seeds. Over a period of weeks or months the main components, which are the worms and the lining bars, lose their performance through abrasion. Breakdown of production and high frequency routine maintenance can be very expensive for the press users. Thus, long service life presents a big challenge to screwpress manufacturers wishing to retain and increase their markets. It has been shown that hardfacing techniques can very effectively extend the service life of a screwpress thus minimise the downtime and maintenance. The worms and the lining bars are first machined from mild steel and then coated with a hardfacing material. All the working surfaces are subsequently machined by milling or grinding to produce the necessary dimensional accuracy and surface finish.

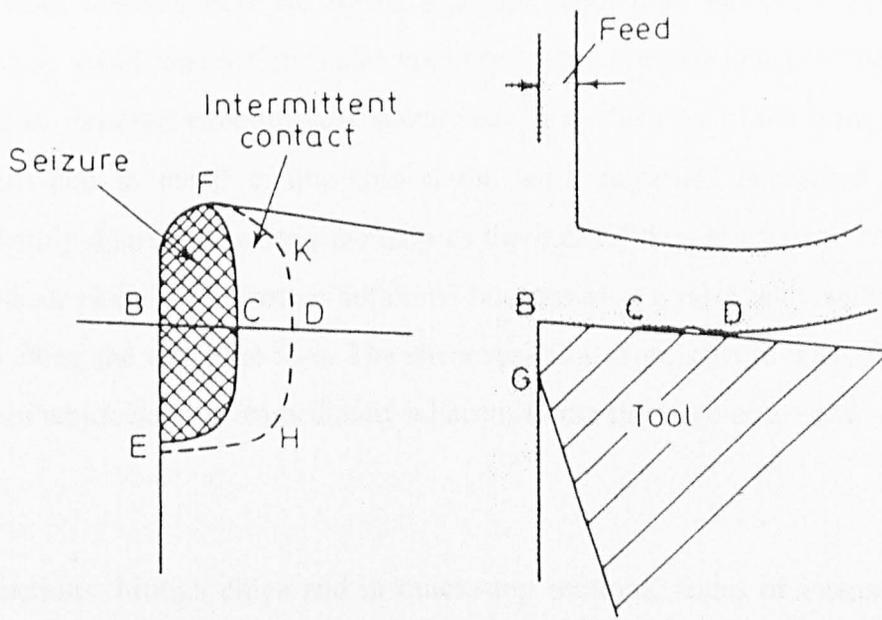
Figure 2.3 Area of seizure on cutting tool (Trent, 1991).

The movement of the chip and the work material across the faces and around the edges of the tool is of great importance in a cutting process. Initially, it was treated as a classical friction process. However, detailed studies of the tool/work surface have shown that this approach was inappropriate for most cutting conditions. Much research has been undertaken using different techniques to study the interface under different cutting conditions (Trent, 1991). The most important conclusion from these observations was that the contact between tool and work surfaces was so nearly complete over a large part of the total area of the interface that sliding at the interface is impossible under most cutting conditions. It has been observed that seizure occurs on the flank surface under some conditions, particularly close to the edge. Sliding occurs under certain cutting conditions and at a certain position on the tool surface as shown in Figure 2.3.

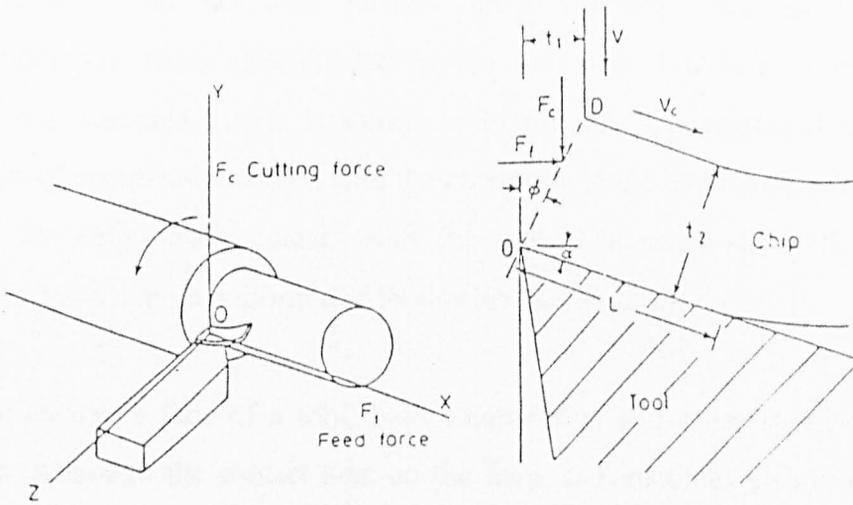
Figure 2.4 Forces acting on cutting tool (Trent, 1991).

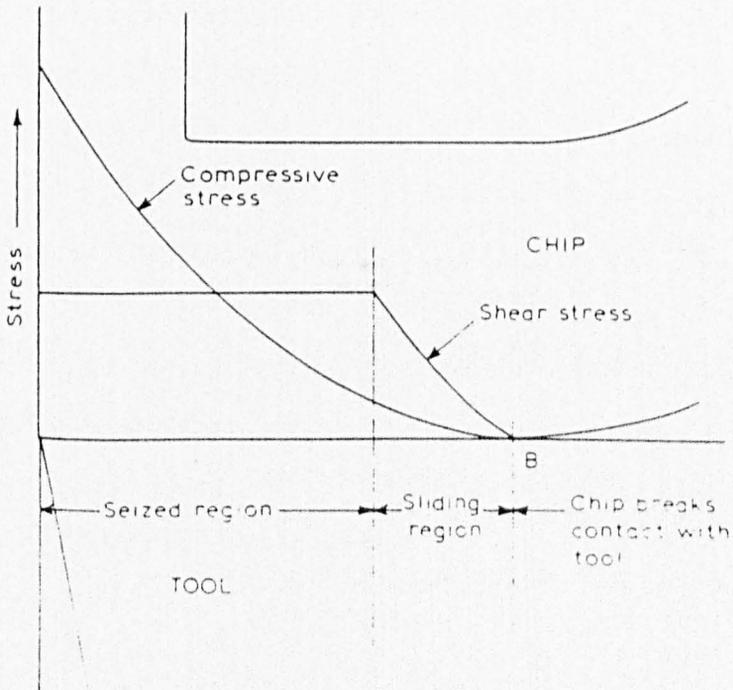
Figure 2.5 Model of stress distribution on tool during cutting (Zorev, 1963).

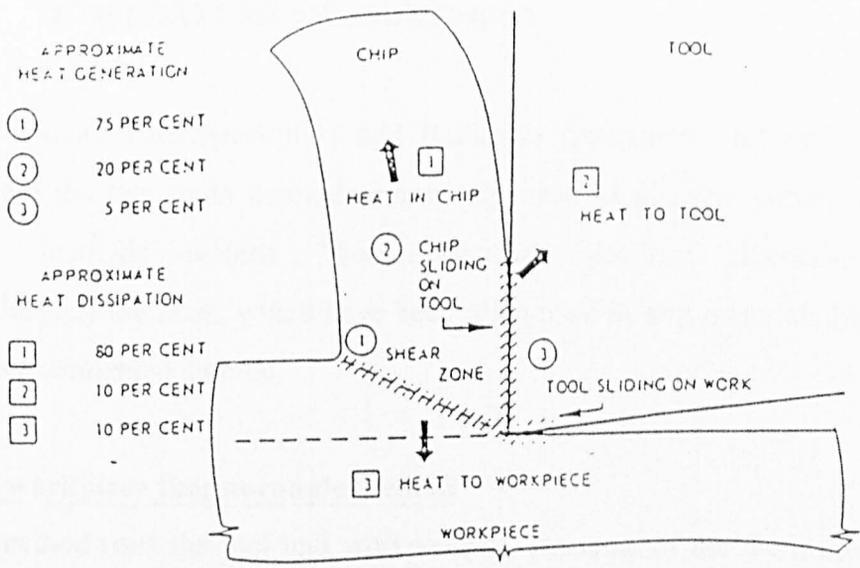
Figure 2.6 Energy partition (heat generation and heat dissipation) in the machining of steel (Komonduri, 1982).

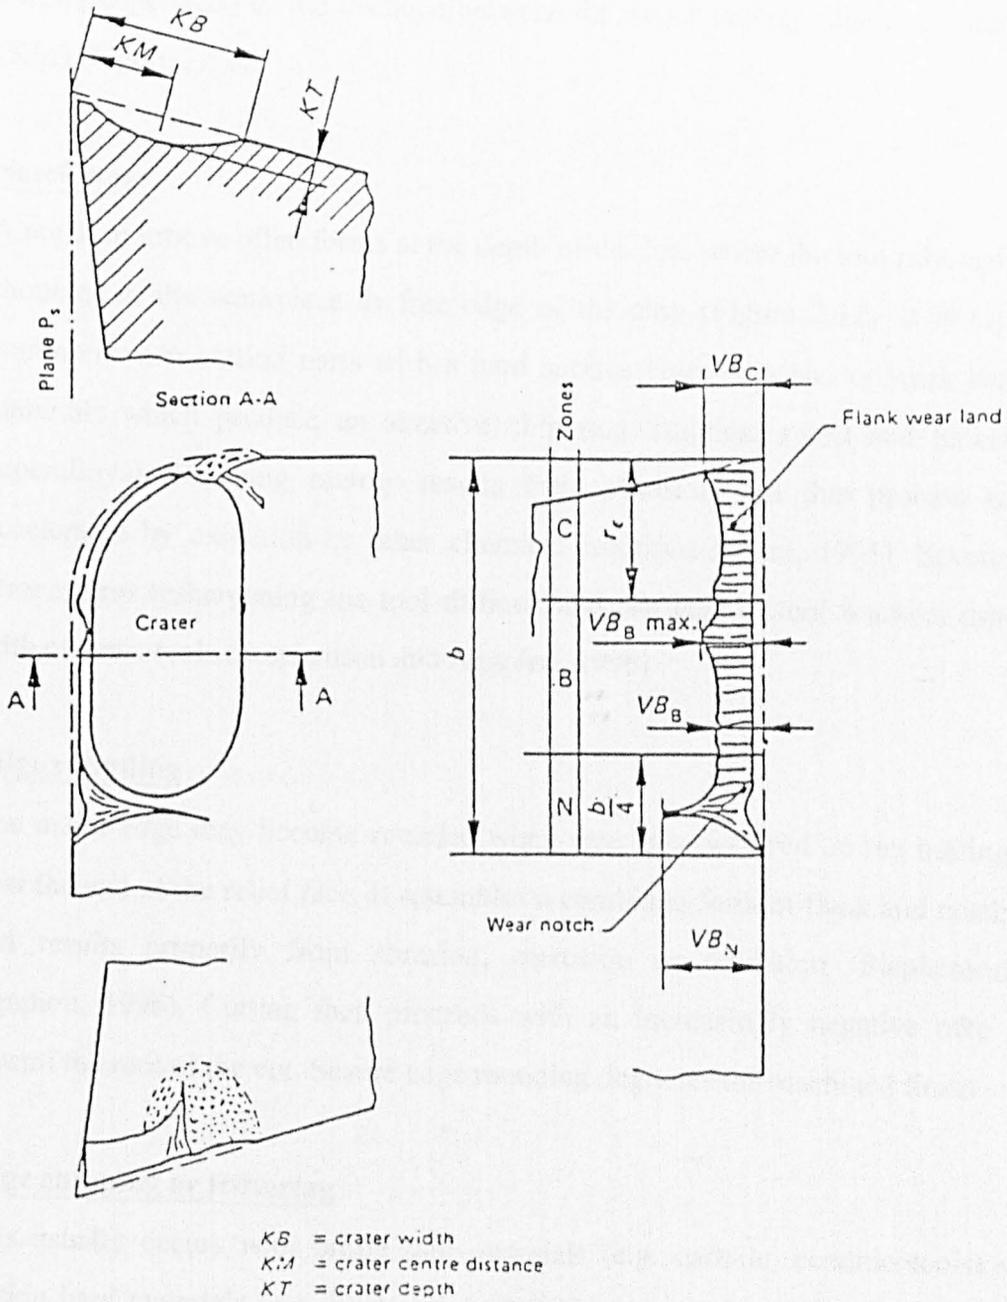
Figure 2.12 Types of wear on turning tools after BS 5623 (1979).

Crater wear or rake face wear produces a damage some distance away from the tool edge on the tool face (Figure 2.12). The high temperatures generated on the rake face combine with shear stresses to create a crater. Moderate crater wear usually does not limit tool life. In fact, crater formation increases the effective rake angle of the tool and thus may reduce cutting force (Stephenson and Agapiou, 1996). Under very high speed cutting conditions crater wear is often the factor that determines the life of the cutting tool, since the cratering becomes so severe that the tool edge is weakened and

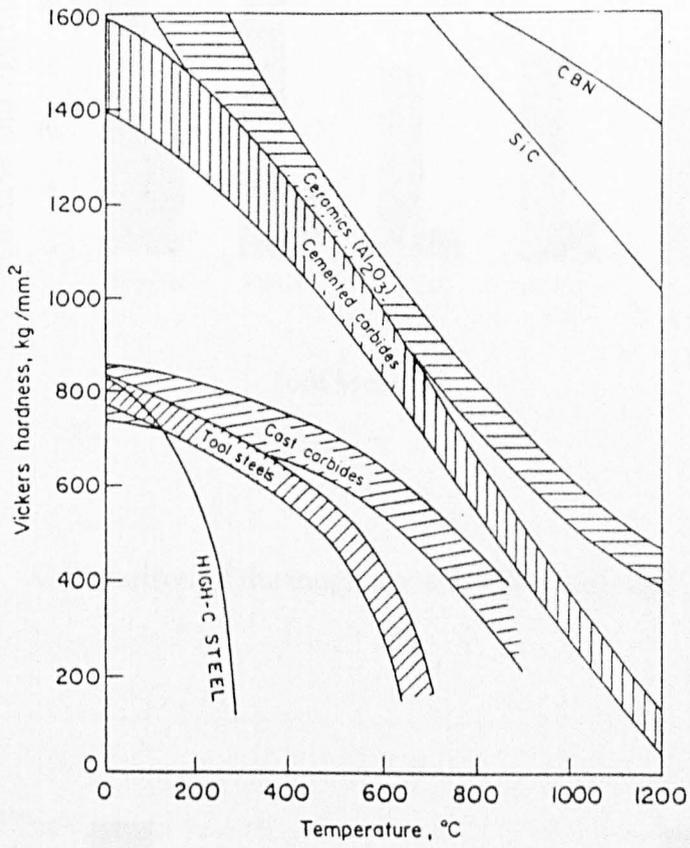
Figure 2.16 Hardness of cutting tool materials at elevated temperatures (Schey, 1987)

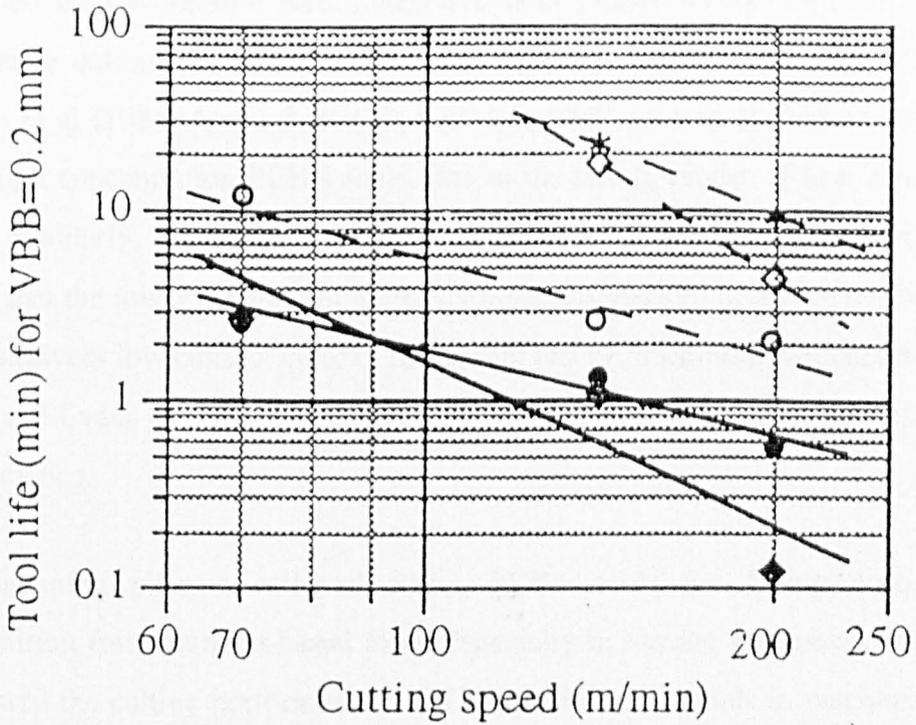
Figure 2.19 Cutting performance of PCBN tools with high and low cBN content. (Abrao et al, 1995)

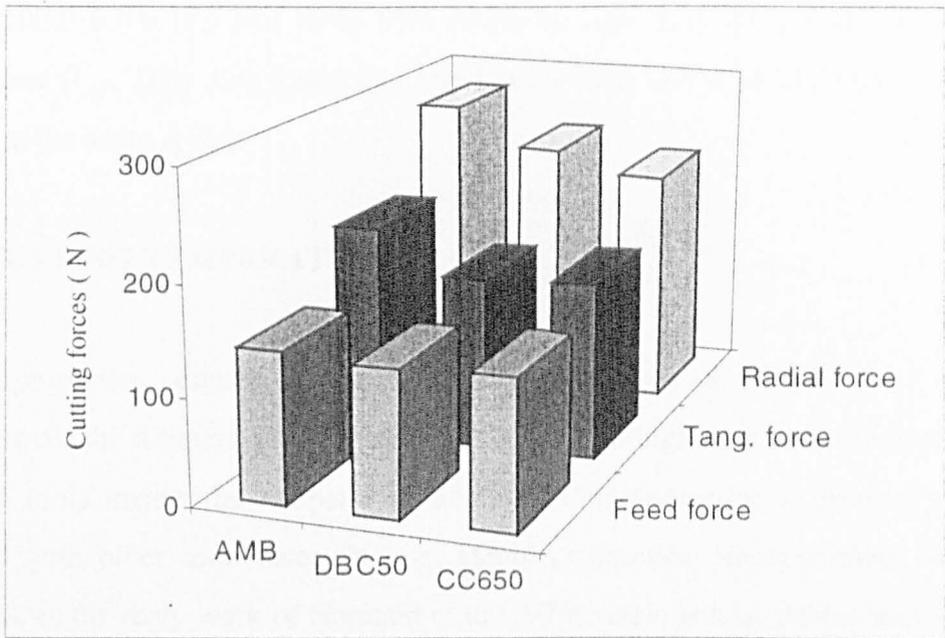
Finish cutting (S200m/min, F0.06mm/rev, DOC0.5mm/side)

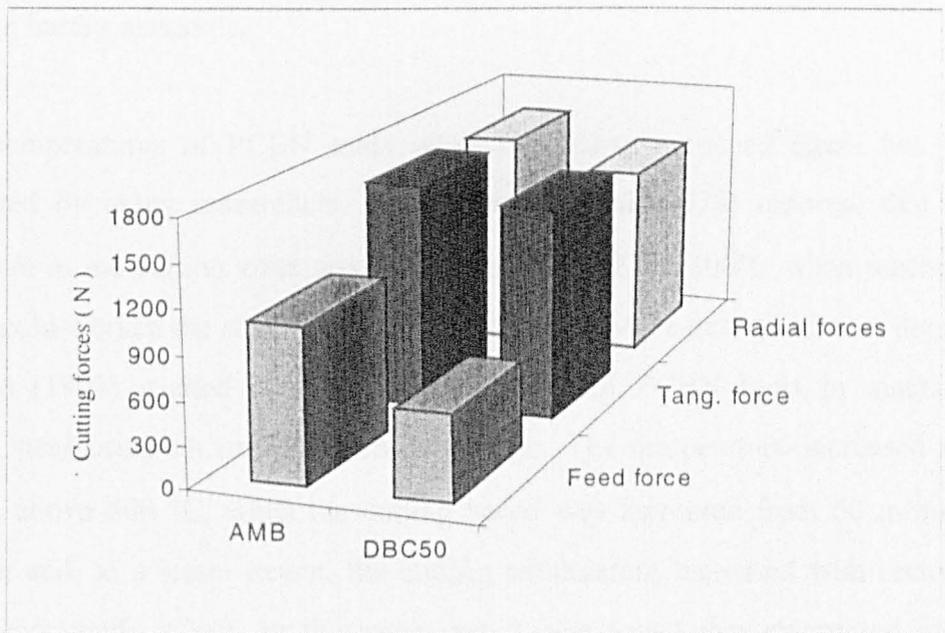
Rough cutting (S70m/min, F0.25mm/rev, DOC2.0mm/side)

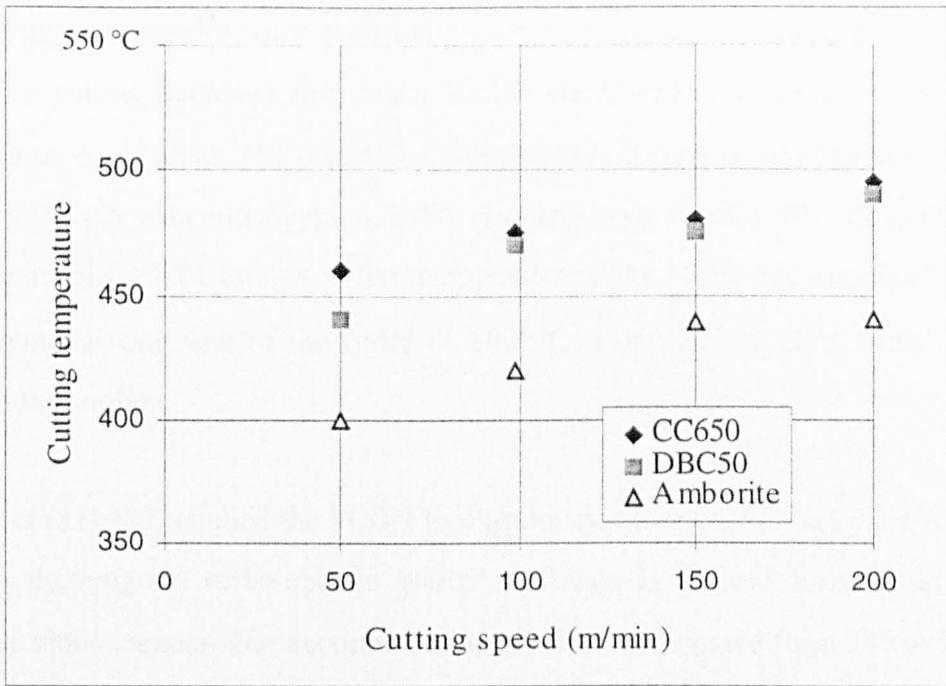
Figure 2.21 Effect of cutting speed on temperature of swarf leaving cutting zone of given inserts: feedrate 0.06 mm/rev, depth of cut 0.5mm (Abrao et al, 1997)

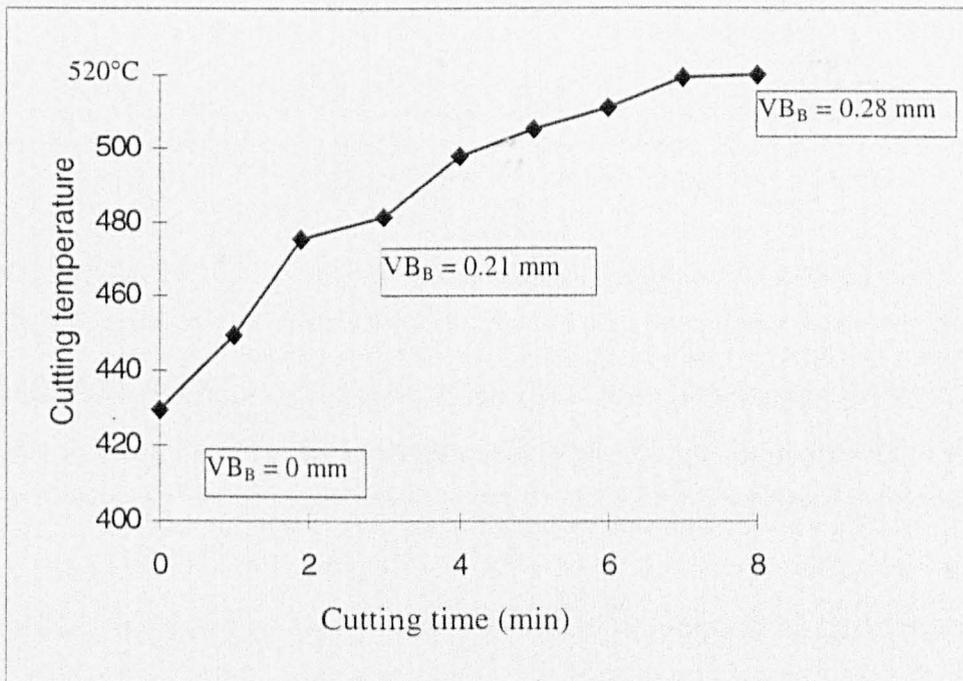
Figure 2.22 Effect of tool wear on temperature of swarf leaving cutting zone of Amborite inserts: cutting speed 100 m/min, feedrate 0.06 mm/rev, depth of cut 0.5mm (Abrao et al, 1996)

Cutting temperatures of PCBN tools when machining hardened steels has been investigated by many researchers. Bhattacharyya et al (1978) reported that the temperature in the cutting zone was in the region of 1275-1300°C when machining AISI D3 cold worked die steel at 60m/min, 0.12 mm/rev feedrate and 2 mm depth of cut. Chen (1993) studied the cutting temperature of PCBN tools in machining hardened steel using an implanted thermocouple. The temperature increased from 300°C to above 800 °C, when the cutting speed was increased from 60 m/min to 150m/min and, to a lesser extent, the cutting temperature increased with increased feedrate and depth of cut. In the same test it was found that chamfered inserts generated lower cutting temperatures than unchamfered inserts at low speed, while at higher speed the situation was reversed. Similarly, in later work when machining bearing steel (Abrao and Aspinwall, 1997), cutting temperature was found to increase with cutting speed (Figure 2.21). Amborite gave the lowest temperature than other tools due to its high thermal conductivity but cutting temperatures increased greatly with tool wear after longer cutting times (Figure 2.22).

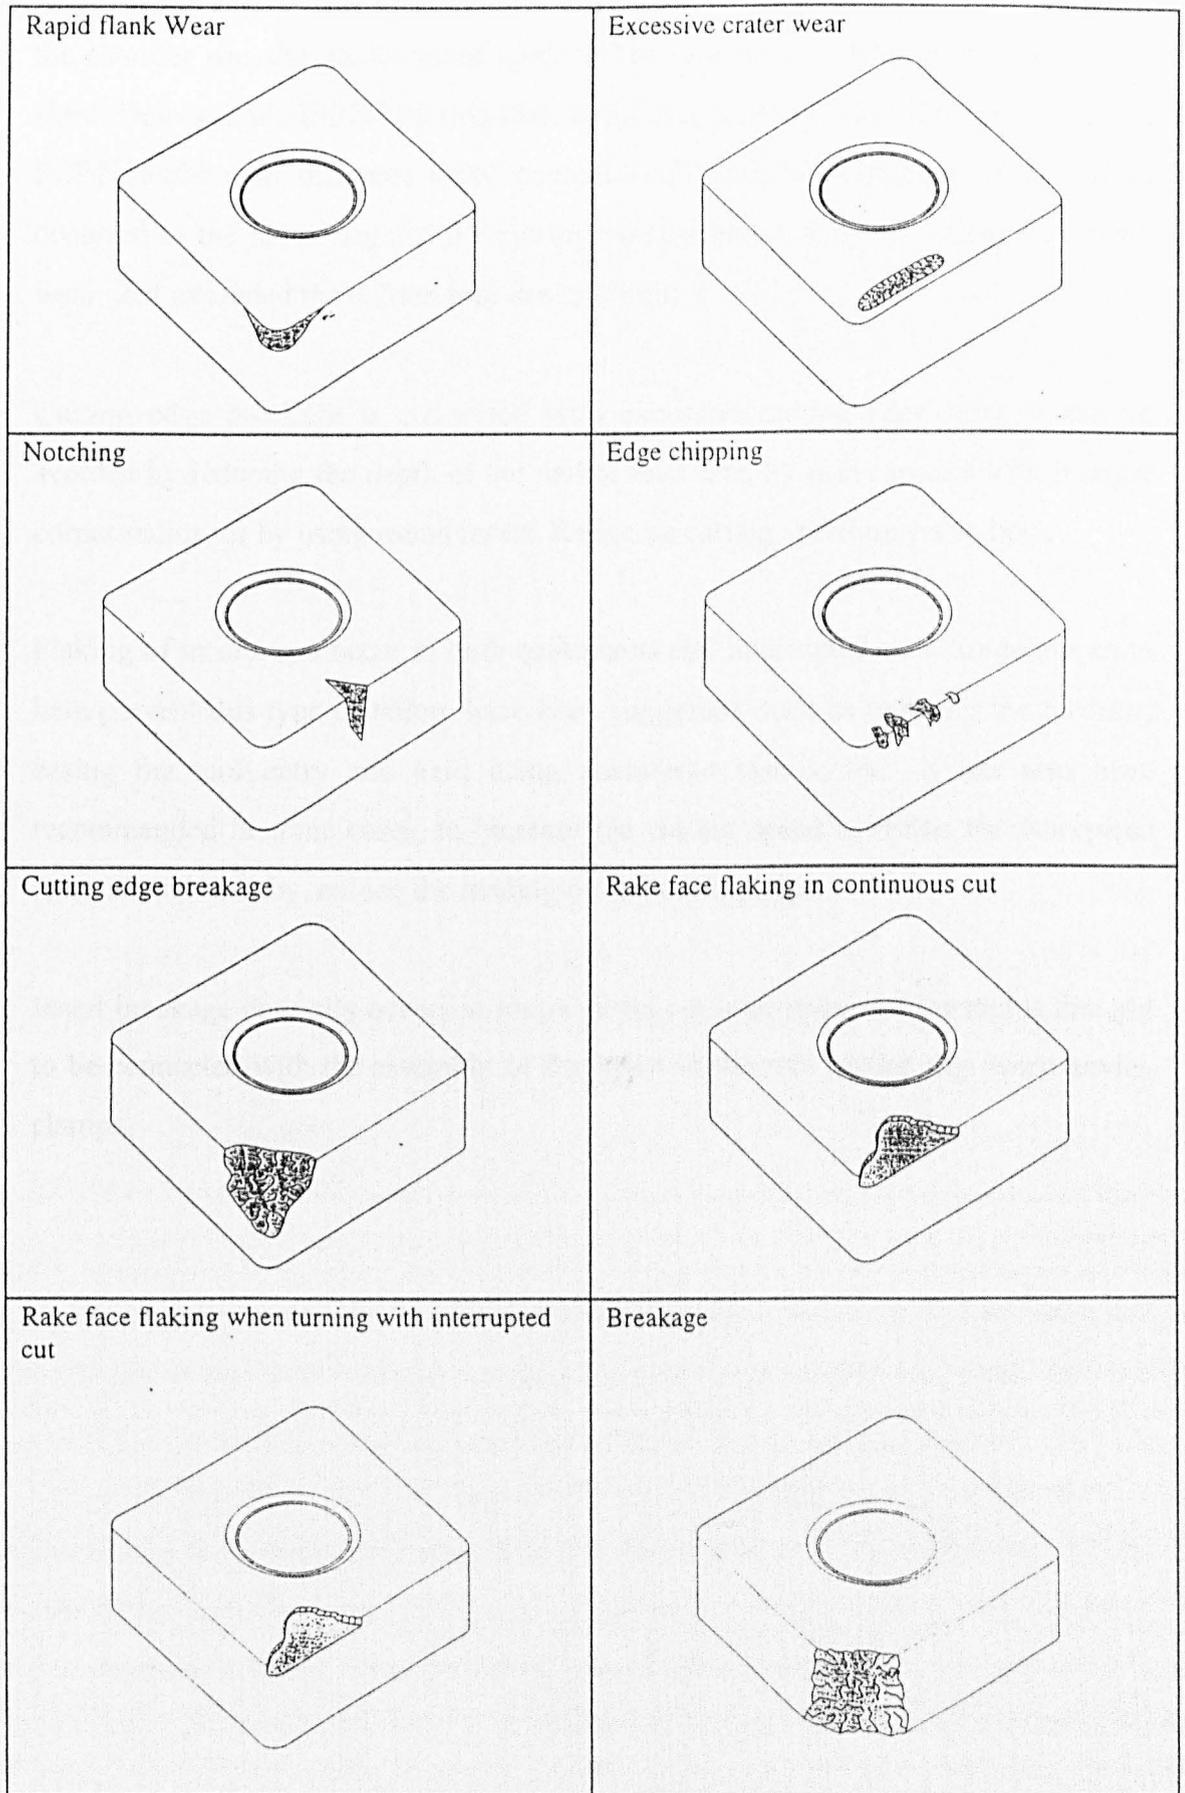
Figure 2.23 Wear mode of PCBN tools (Seco Ltd, 1996)

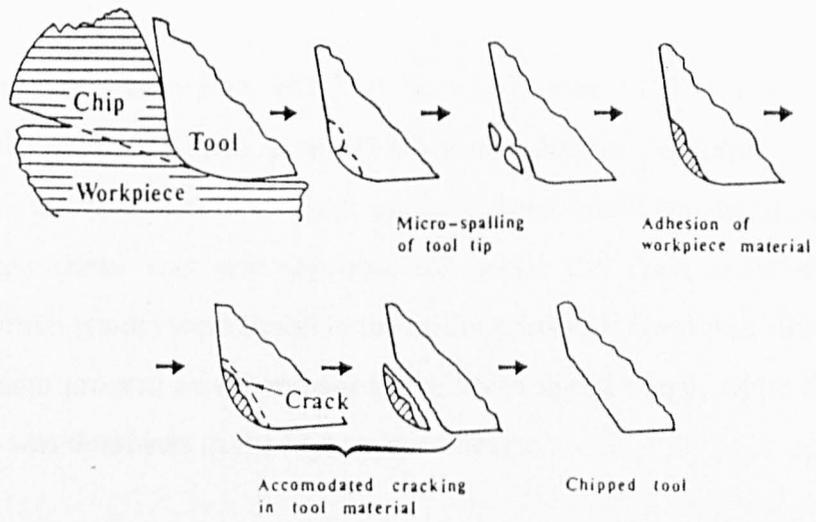
Figure 2.24 Schematic representation of chipping process of PCBN tools (Shintani et al, 1989)

In the research on optimum tool geometry of PCBN tools for continuous turning of carburized steel (Shintani et al, 1989), it was found that in the earlier stages, frequent chipping occurred caused by high stresses generated on the tool edge. In the later stages, a type of adhesive wear was involved in the development of the chipping process, as shown in Figure 2.24. As a result of chipping, a step-wise increase in the cutting force occurred. Another result observed in their experiment was grooving wear of the side cutting edge due to oxidation when using narrow negative land tools.

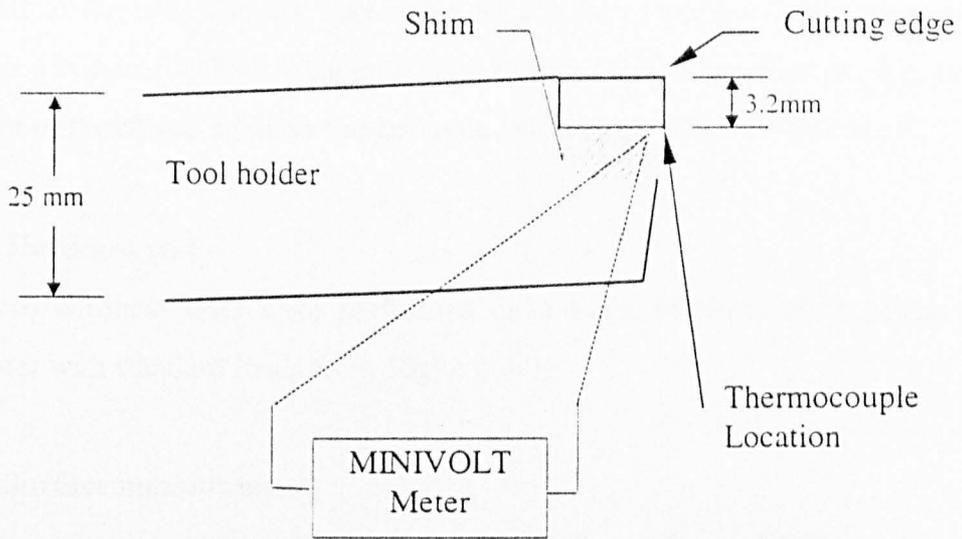
Figure 3.3 Schematic to show the set-up of the temperature measurement system.

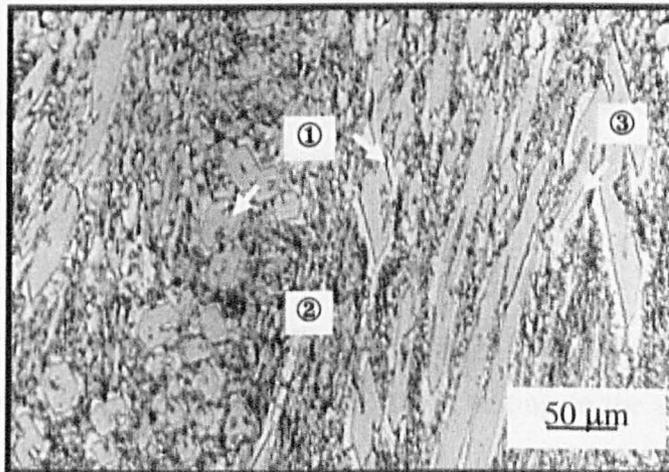
b) Hardfacing with coarse structure (Hardfacing B), ① Primary carbide, ② Fine carbides carbides in  $\gamma$  matrix, ③ Carbide free region

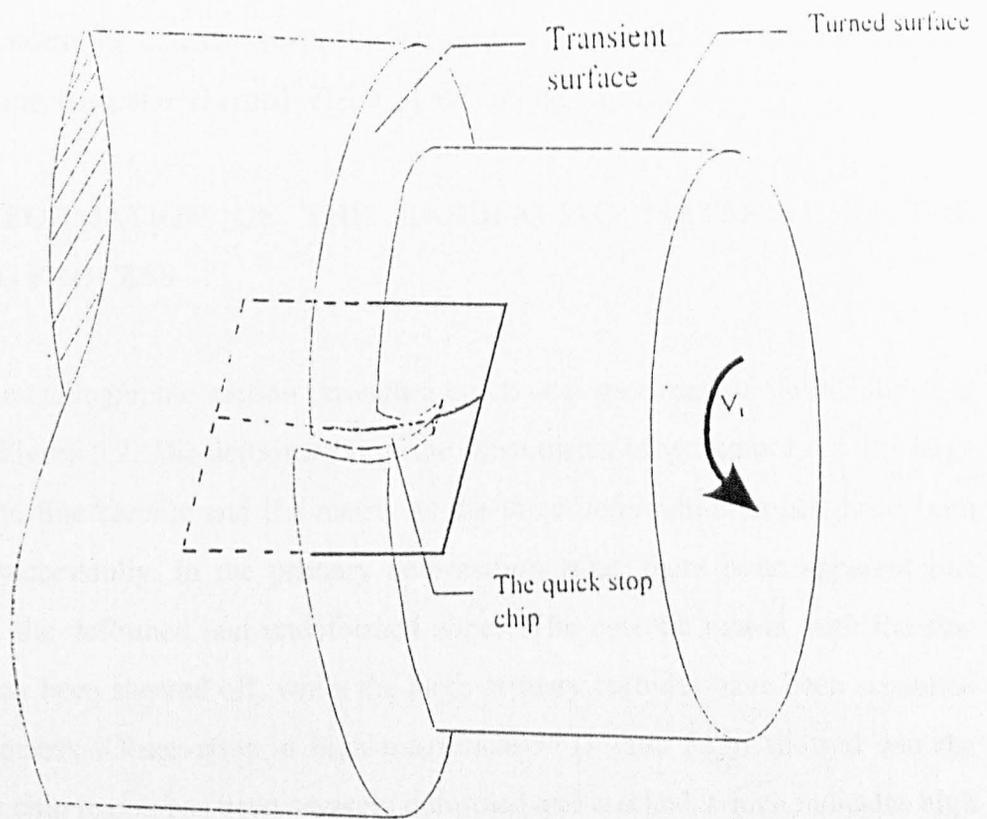
Figure 5.1 Schematic to show the chip attached to the parent workpiece after the quick stop.

In a machining process, the chip is separated from the workpiece on the transient, newly formed, surface (Figure 5.1), which is under direct contact with the cutting edge and the flank face of the insert. Therefore, the subsurface structure of the transient surface may well reflect the deformation behaviour of the constituents of

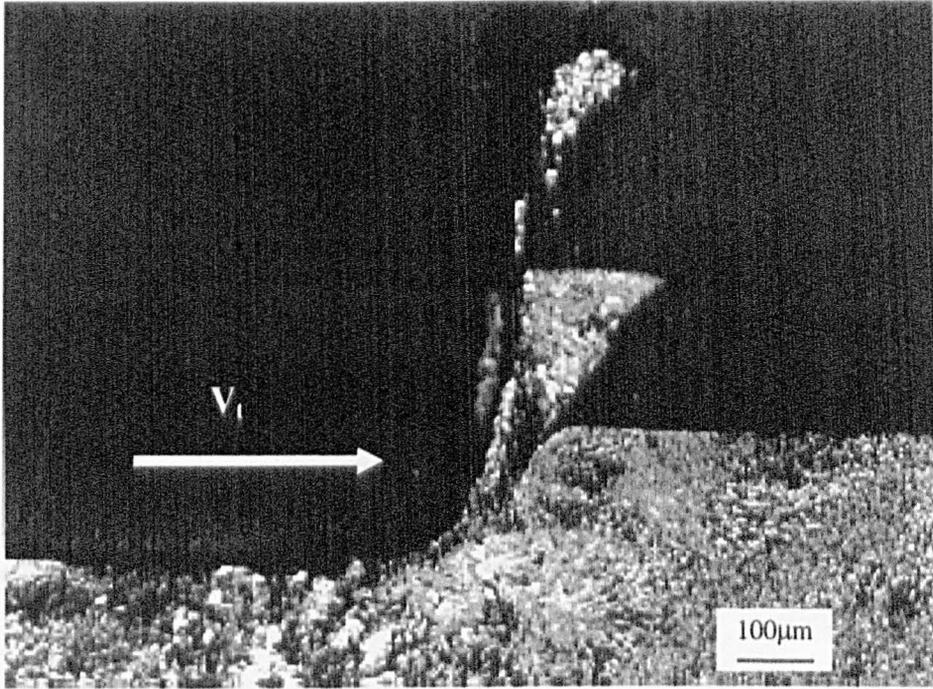
a) General view

Figure 5.3a shows a typical quick-stop sample of Hardfacing B. On the orthogonal plane, the primary carbides shows different section shapes in relation to their orientation to the cutting edge. The columnar grains (A) are carbides roughly perpendicular to the cutting edge, while the hexagonal grains (B) are representative of those roughly parallel to the cutting edge. In the workpiece, most of the primary

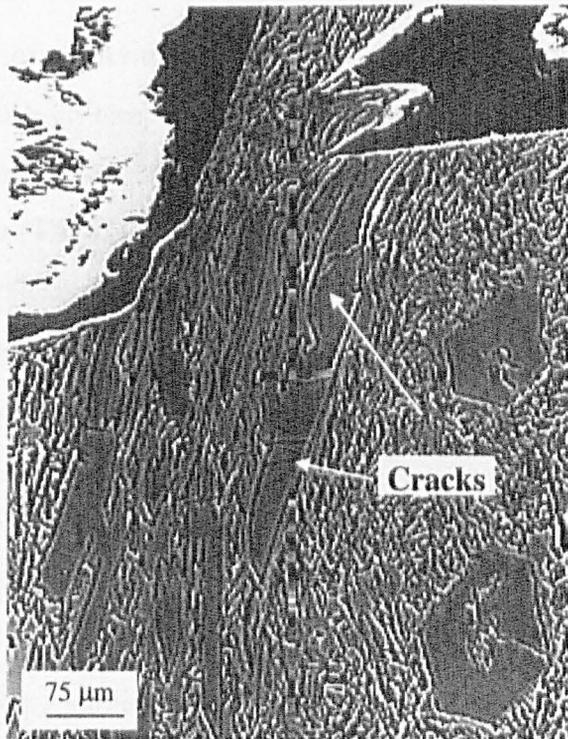
b) Enlarged view showing cracking of primary carbides around the cutting edge.

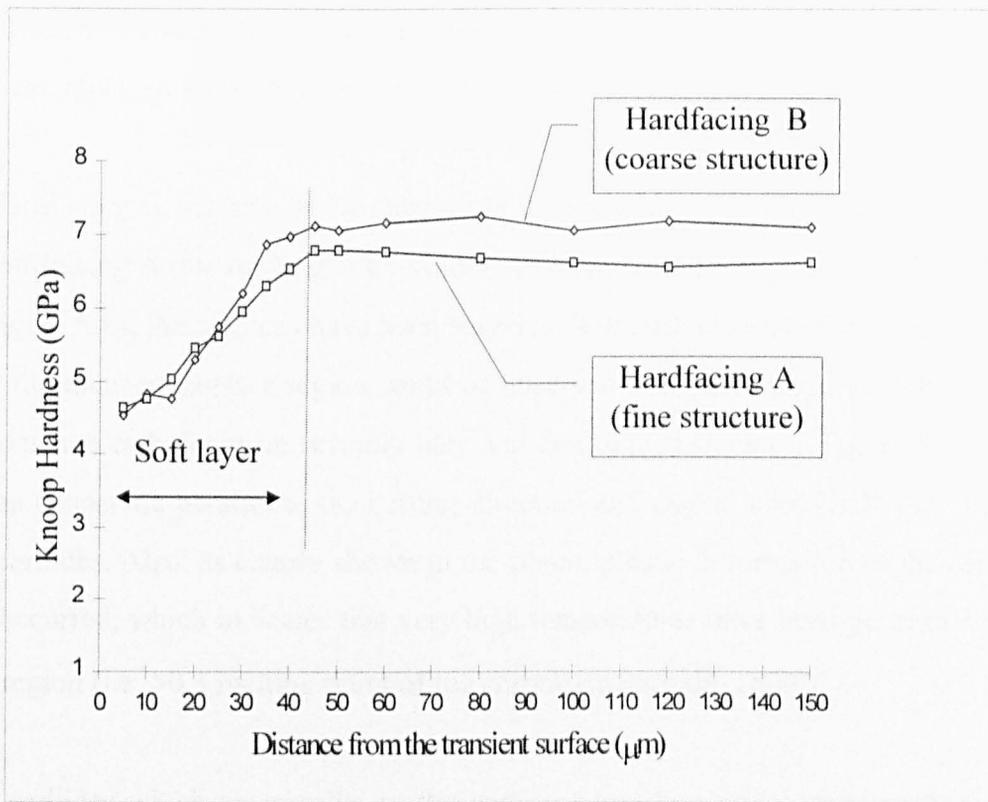
**Figure 5.6** Hardness profile beneath the transient surface (load = 200g).

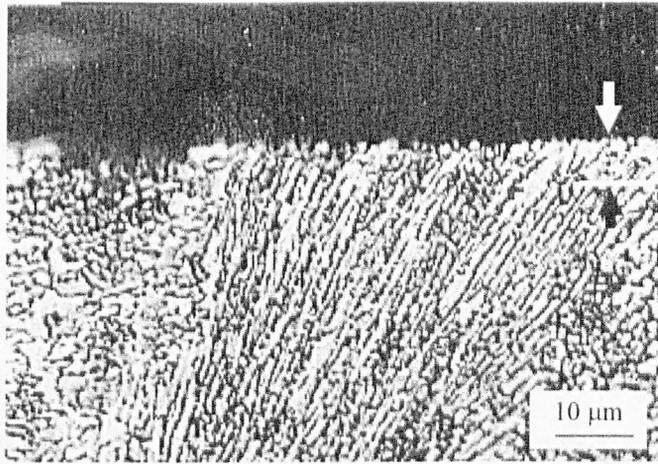
**Figure 5.7** Cross section of the transient surface of Hardfacing A (S65m/min).

Figure 5.7 shows the structure of the cross-section of Hardfacing A. In the region beneath the transient surface (arrowed), a disturbed microstructure exists. The fine carbides have been bent slightly in the cutting direction by the action of the tool. In addition, the carbides had been fragmented at the surface region. The mechanically-disturbed layer is much shallower than the region with lower hardness, as shown in Figure 5.6. This demonstrates that the thermal effects involved in the cutting process have determined the depth of the affected layer. Observation of the larger carbides at

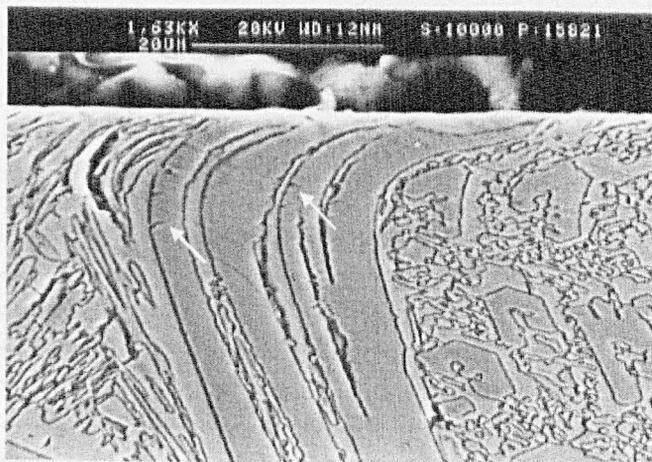
b) Cracking of large carbides

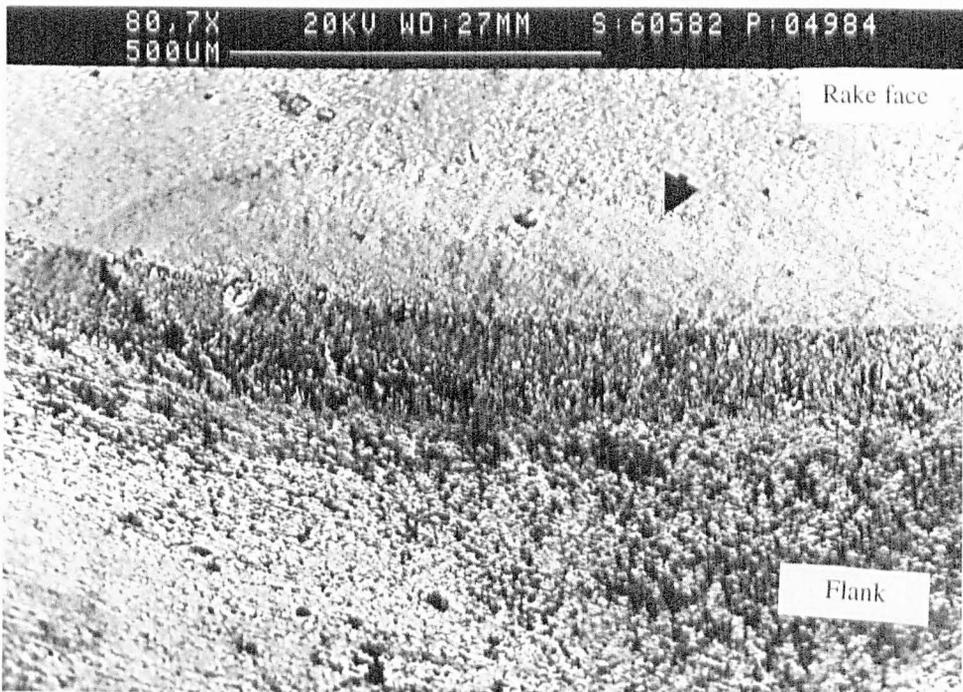
**Figure 6.1a** Chip-tool contact area in the cutting process.

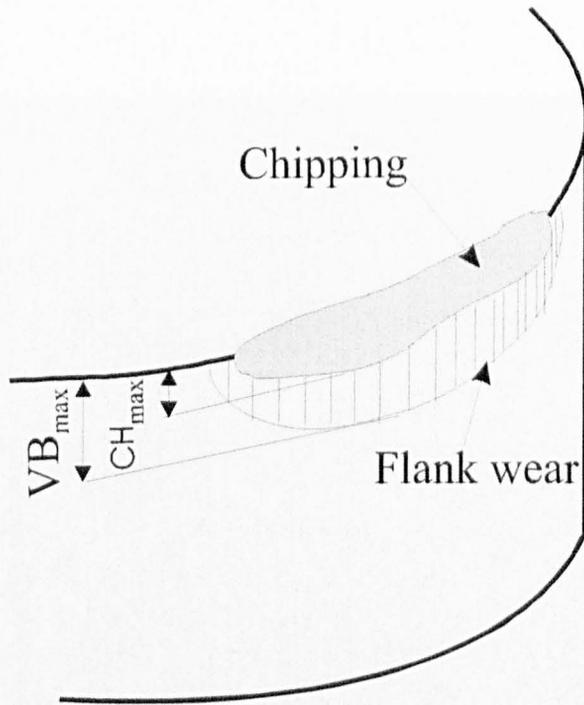
**Figure 6.2** Schematic to show typical tool wear mode and the definition of  $VB_{max}$  and  $CH_{max}$ .

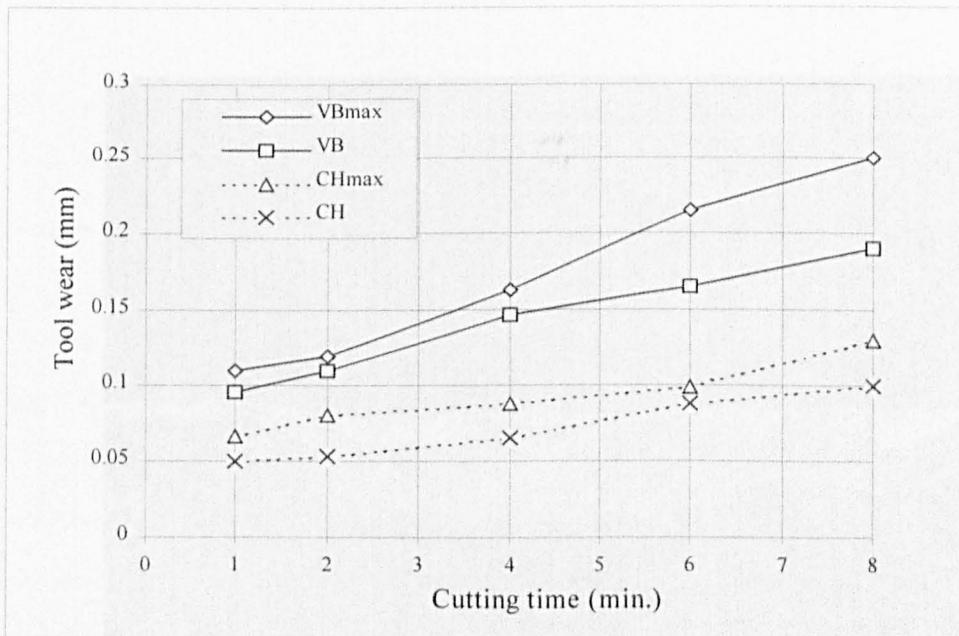
**Figure 6.3** Tool wear vs. cutting time (S65m/min, F0.25mm/rev, DOC0.65mm).

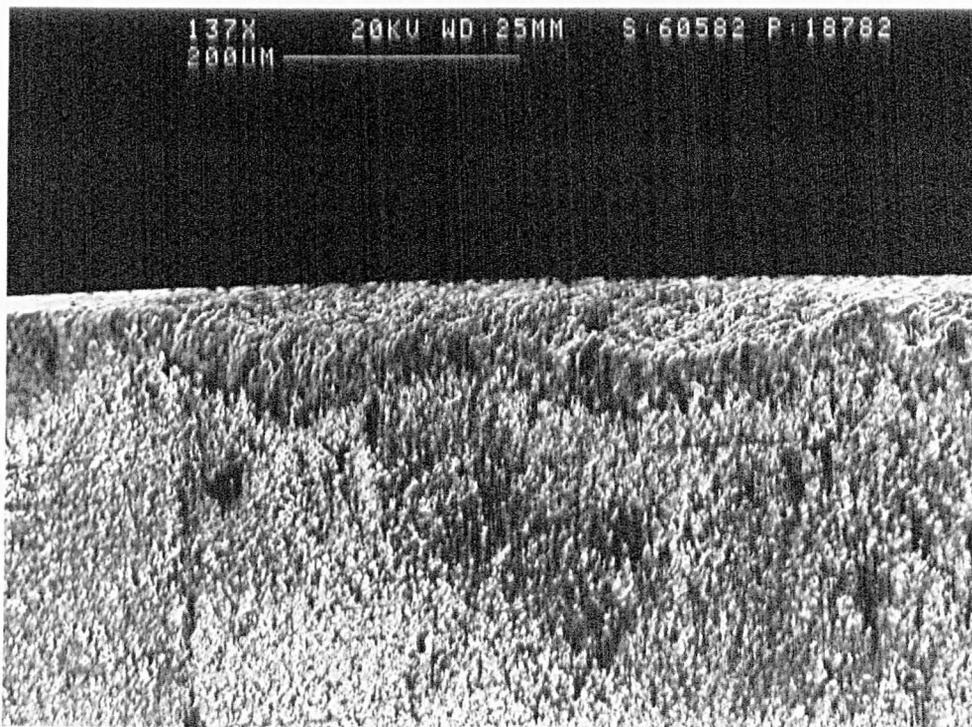
**Figure 6.4a** Chipping and flank wear of tool insert after 1 minute cutting (S65m/min, F0.25mm/rev, DOC0.65mm).

Figure 6.4 shows the chipping and flank wear of the insert after 1 and 8 minutes cutting. Chipping has started at the lower edge of the chamfer and developed on the

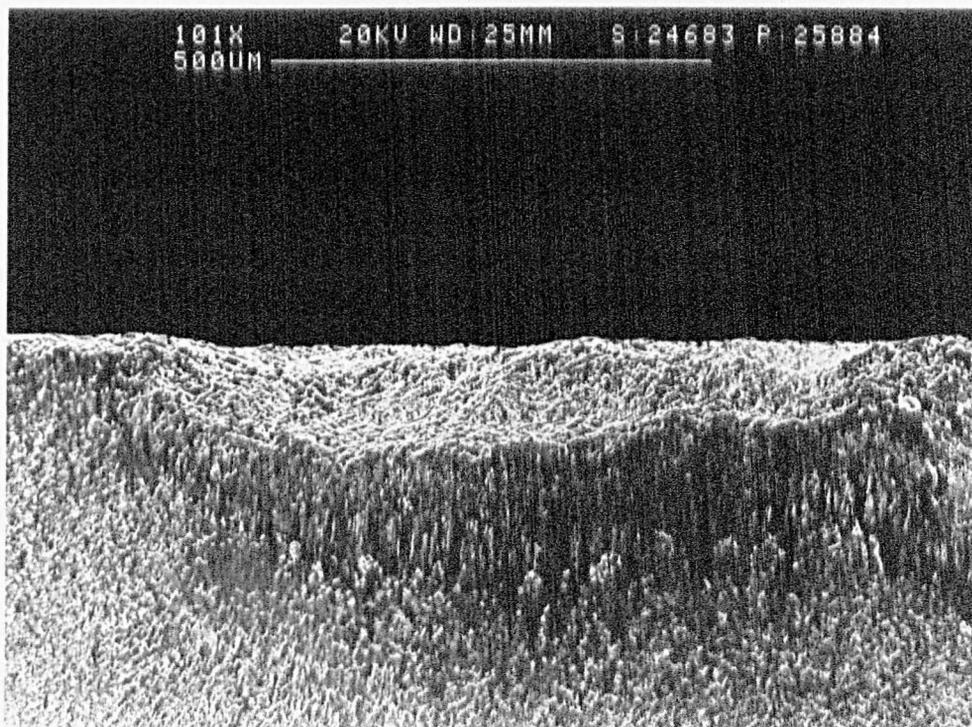
**Figure 6.4b** Chipping and flank wear of the insert after 8 minutes cutting (S65m/min, F0.25mm/rev, DOC0.65mm).

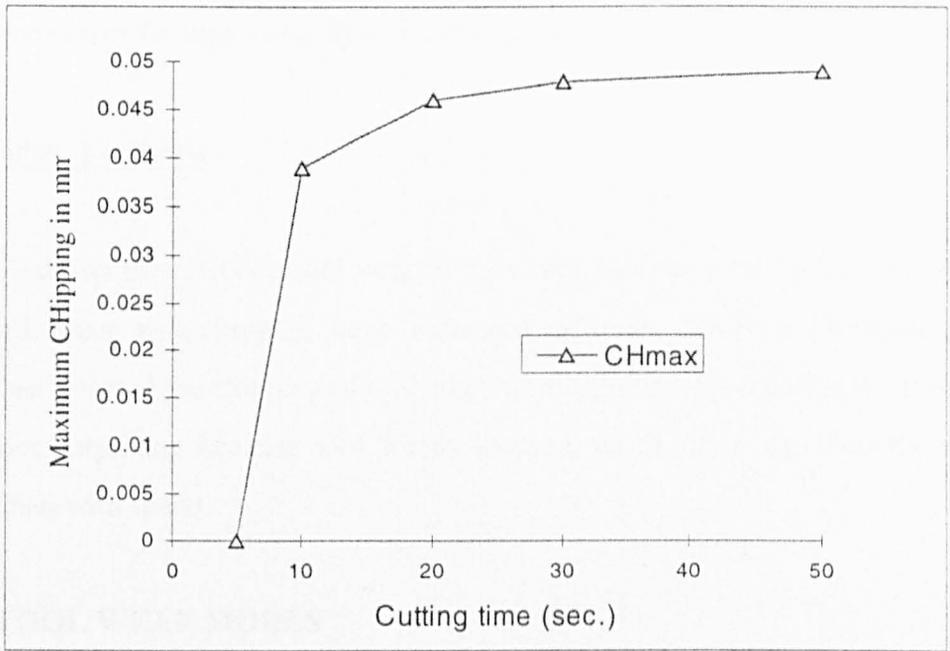
**Figure 6.5** Initiation and development of chipping in early stages of cutting (S65m/min, F0.25mm/rev, DOC0.65mm).

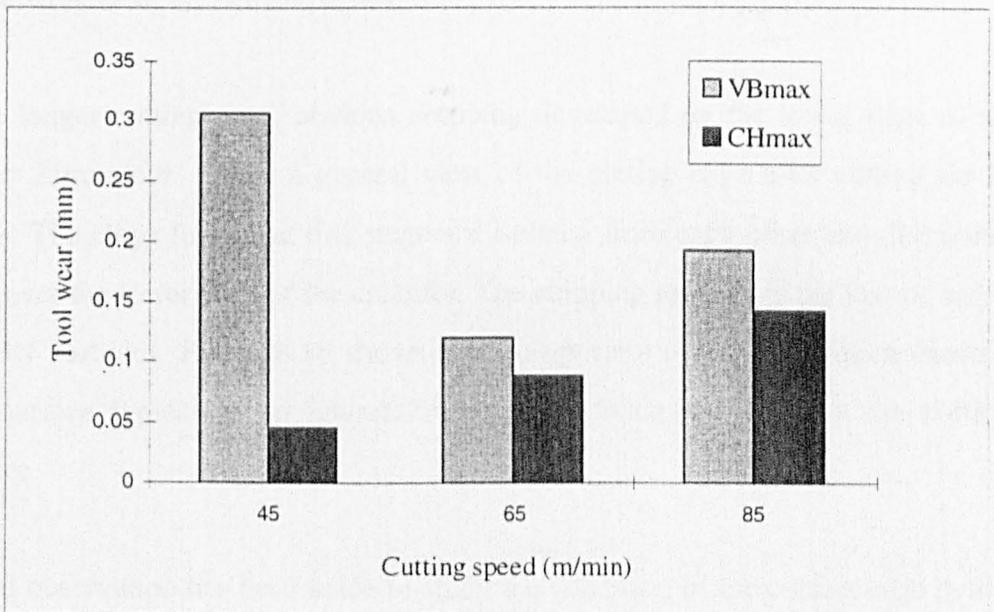
**Figure 6.6** Tool wear vs. cutting speed (1 minute, F0.25mm/rev, DOC0.65mm).

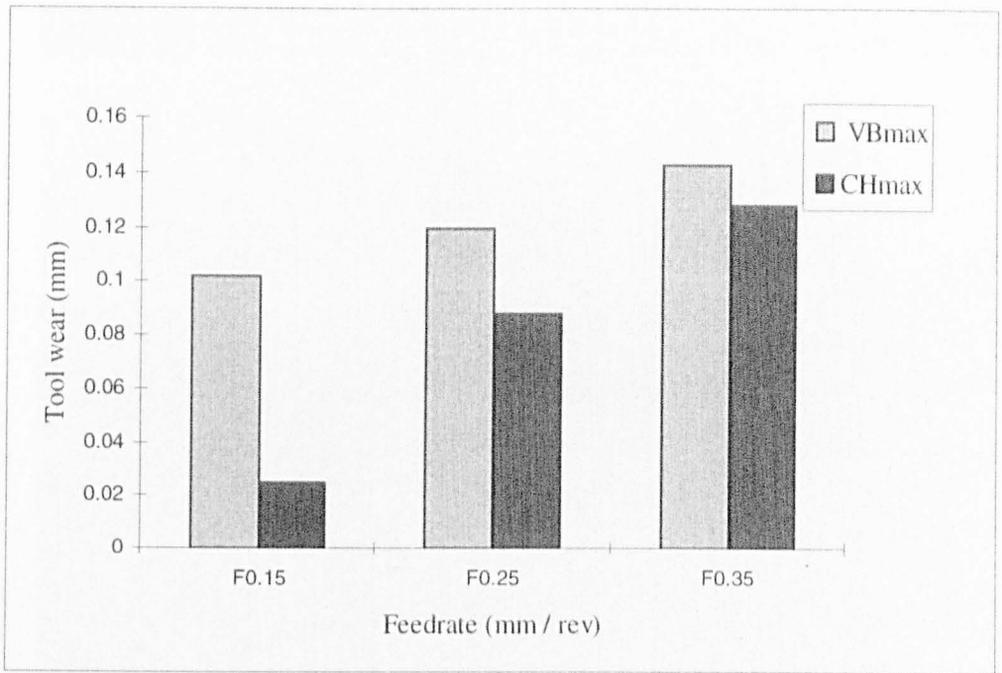
**Figure 6.7** Tool wear vs. feed rate on the tool wear (1 min., S65m/min, DOC0.65).

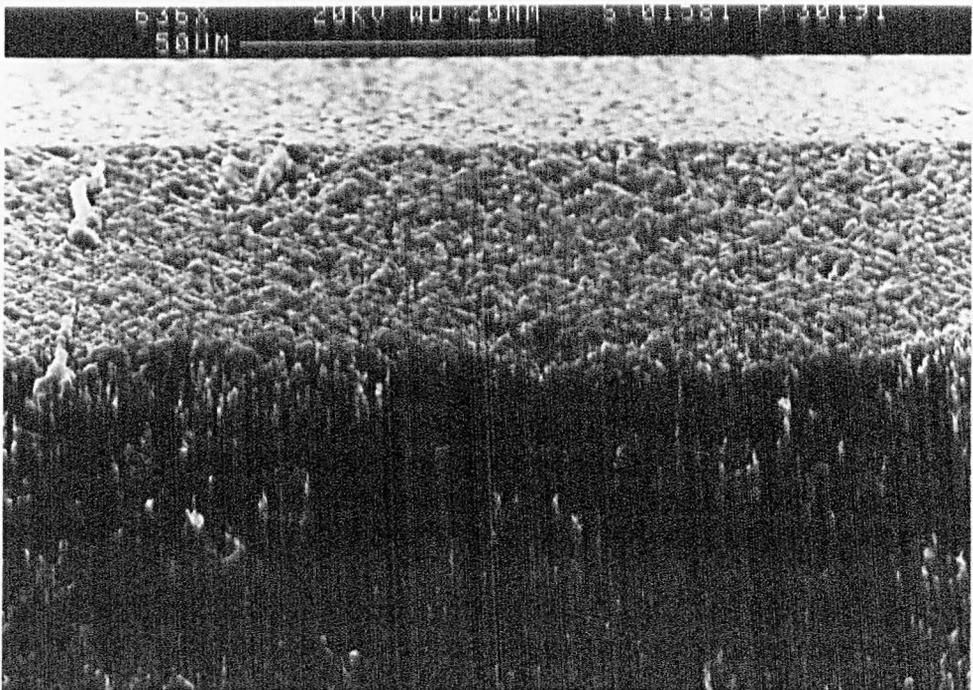
**Figure 6.8** Cutting edge after a very short cutting time cutting (5 secs) showing no chipping damage (S65m/min, F0.25mm/rev, DOC0.65mm).

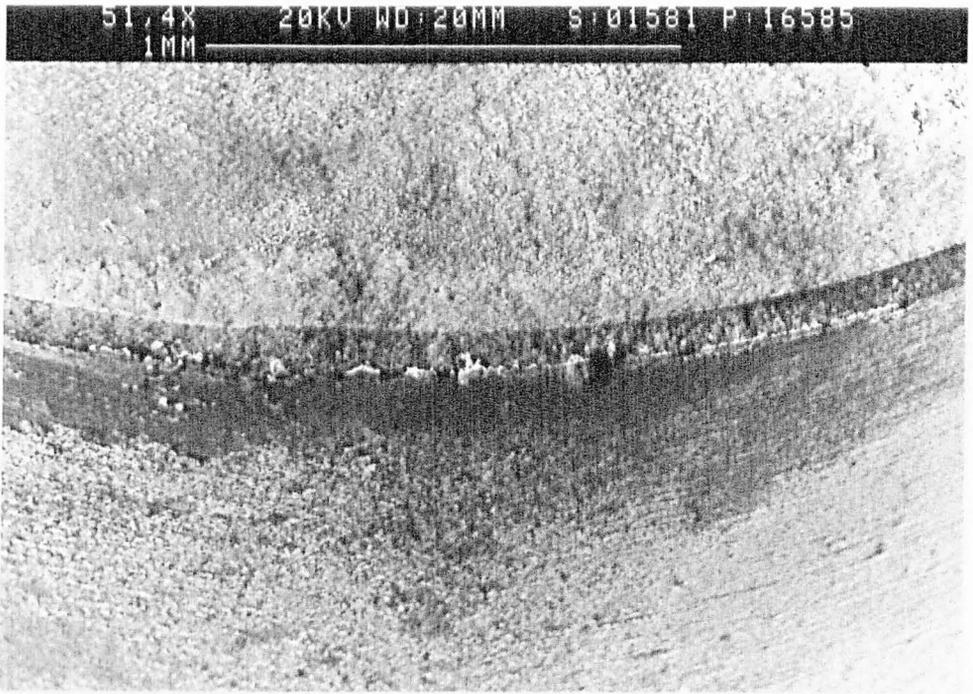
**Figure 6.9** Chipping of the cutting edge after a cutting time of 20 sec (S65m/min, F0.25mm/rev, DOC0.65).
