THE TOOL:WORKPIECE INTERACTION WHEN MACHINING WELDED  
HARDFACING USING PCBN TOOLS

being a Thesis submitted for the Degree of  
DOCTOR OF PHILOSOPHY

XUEJUN REN, BSc MSc

May 2000

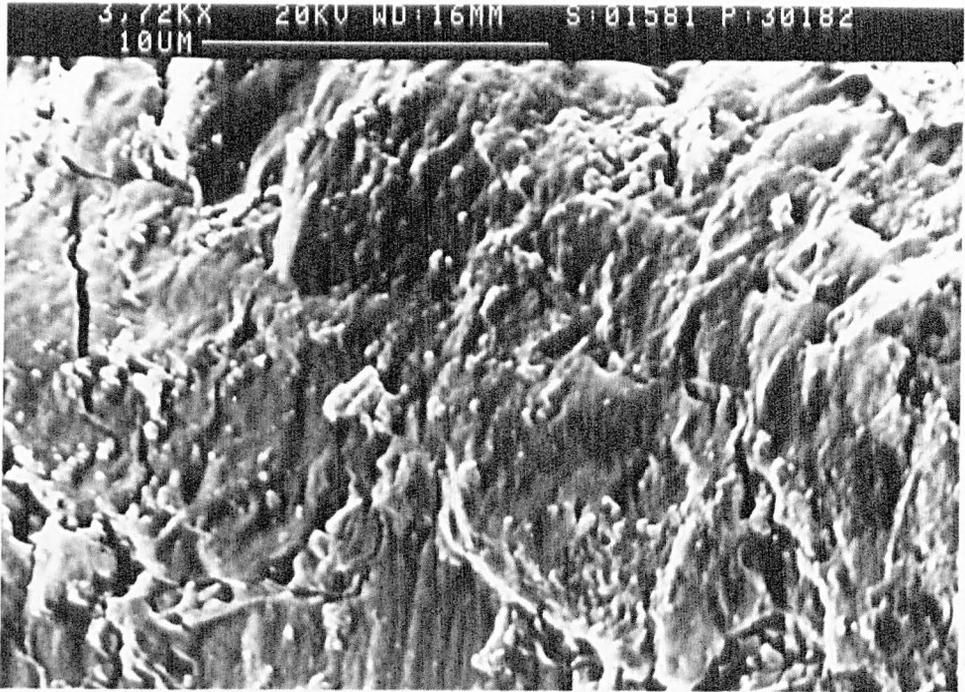
**Figure 6.11** Cracking on the lower edge of the tool chamfer before the edge chipping.

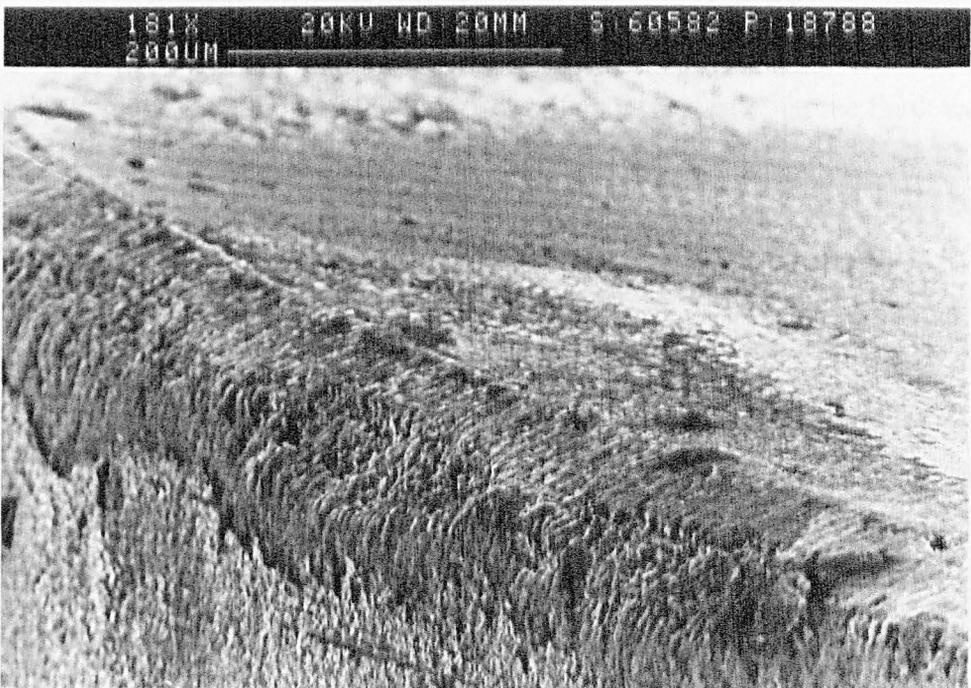
**Figure 6.12** General view of the cutting edge showing chipping developed over the cutting edge (1 minute, S65m/min, F0.25mm/rev, DOC0.65mm).

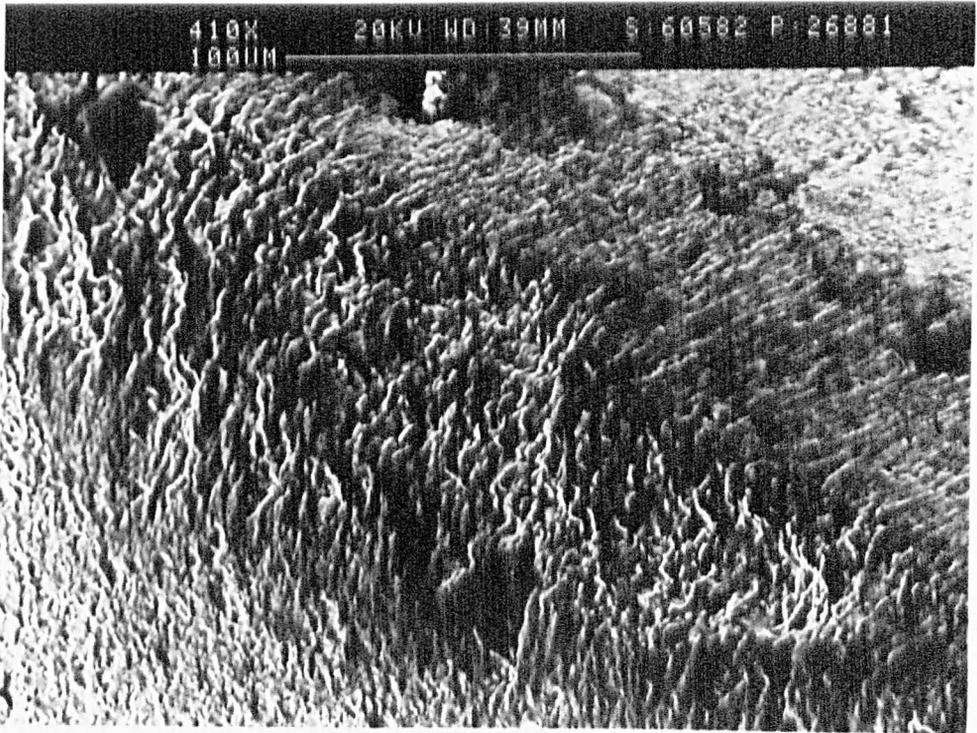
**Figure 6.13a** Chipping developed on the lower edge of the chamfer.

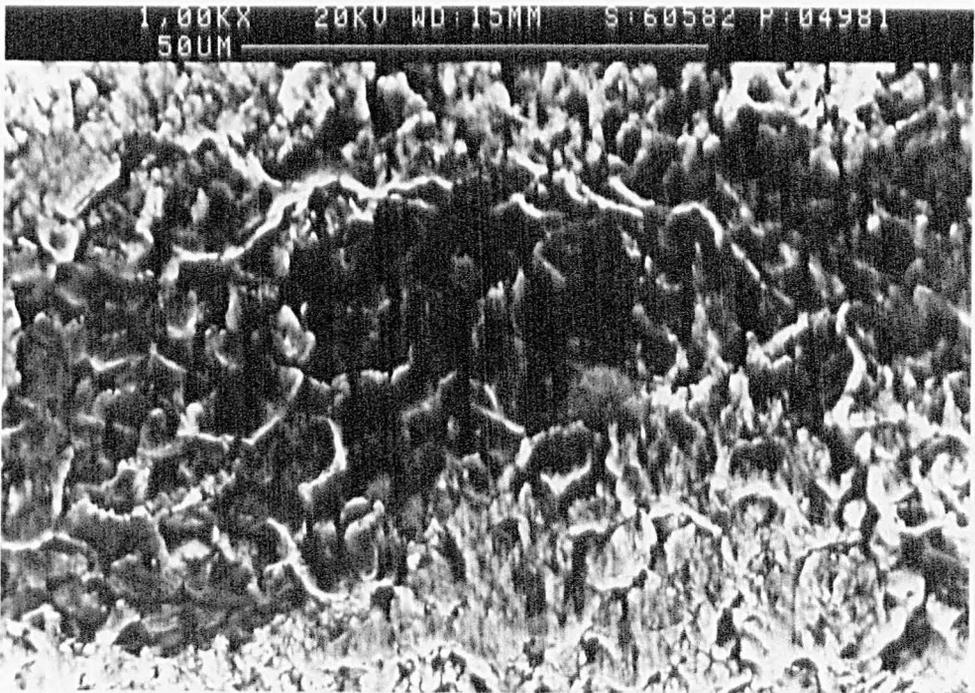
**Figure 6.13b** Enlarged view of one chipped location in a) showing transgranular fracture involved in the chipping process.

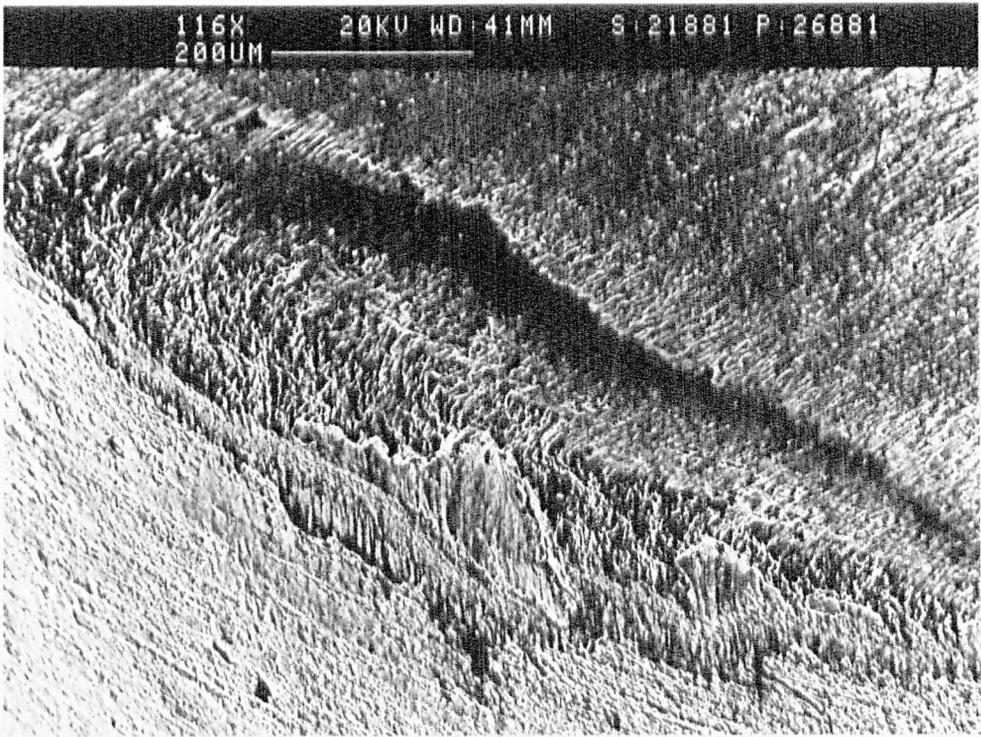
**Figure 6.14a** General view of the cutting edge after cutting for 4 minutes  
(S65m/min, F0.25mm/rev, DOC0.65mm).

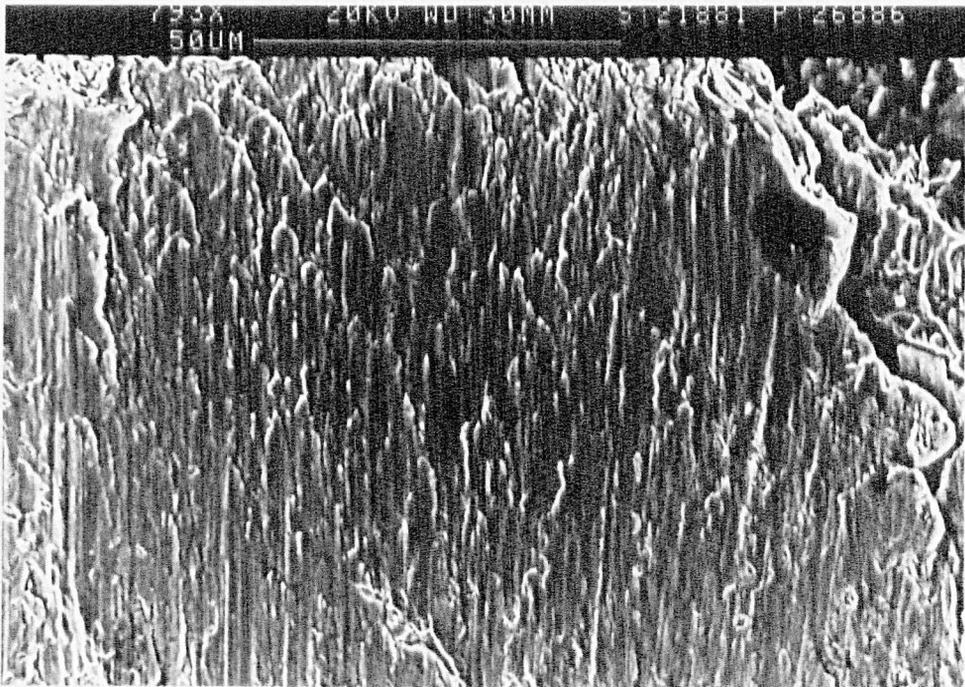
**Figure 6.14b** Enlarged view of a) showing the ridged surface of the flank wear land.

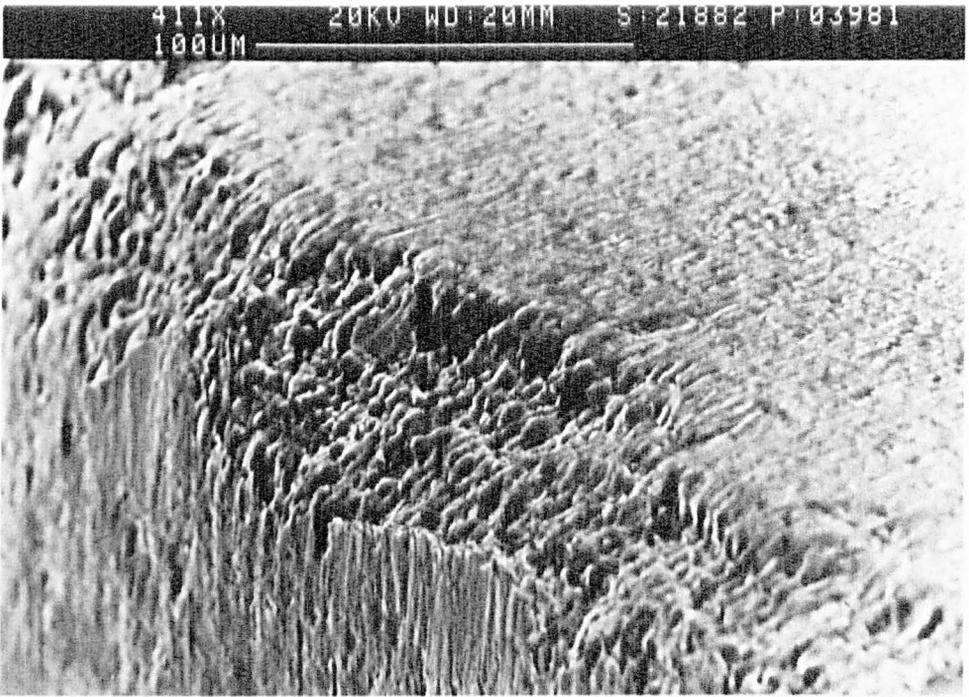
**Figure 6.15a** Wear of the cutting edge showing chipping has developed over the whole chamfer (6 minutes, S65m/min, F0.25mm/rev, DOC0.65mm)

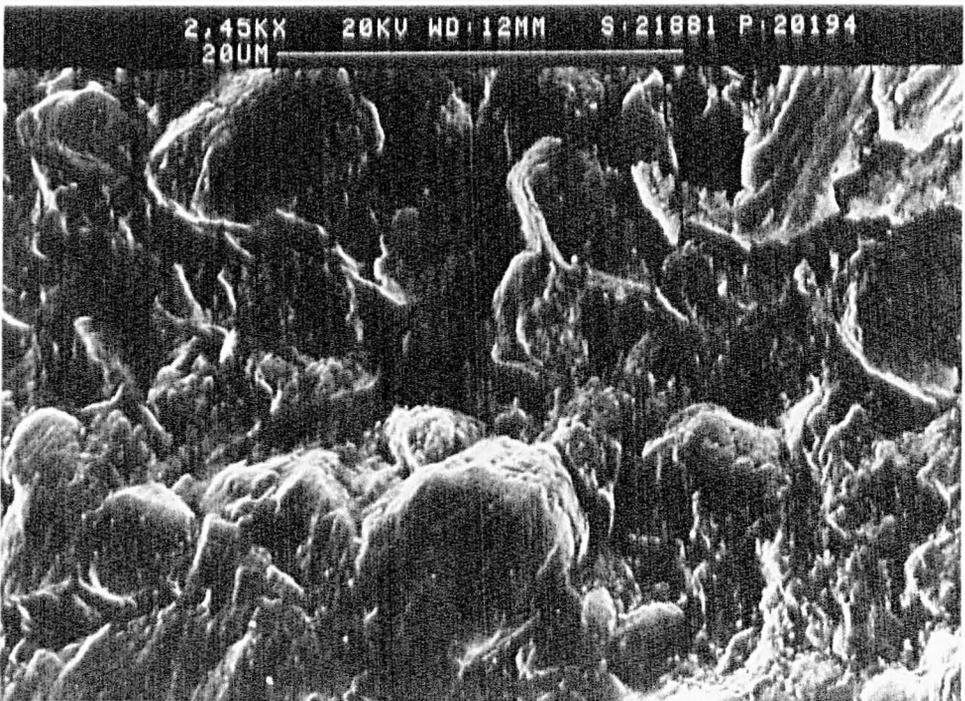
**Figure 6.15b** Enlarged view of a) showing individual CBN particles lost on the chipped surface.

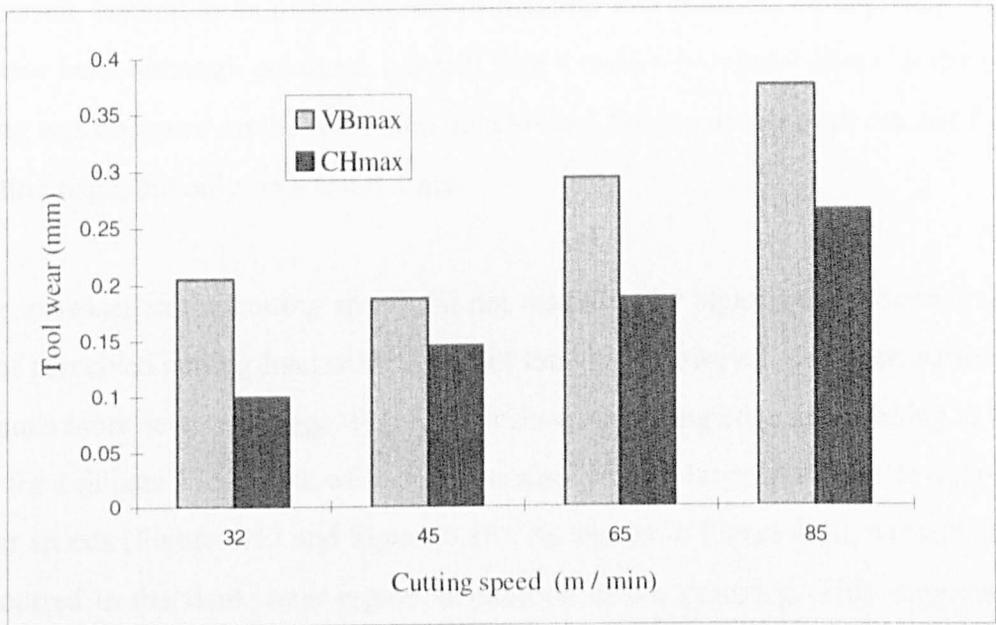
**Figure 6.16** Tool wear vs. cutting speed when machining Hardfacing B (F0.25mm/rev, DOC0.65mm).

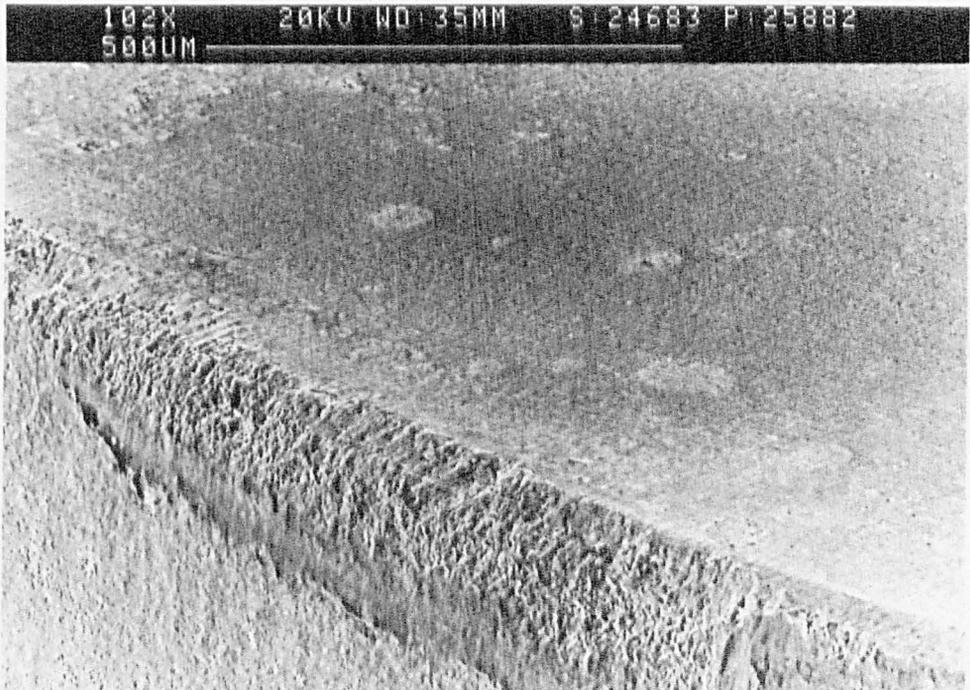
**Figure 6.17** Tool wear mode when machining Hardfacing B at a cutting speed of 45m/min (F0.25mm/rev, DOC0.65mm).

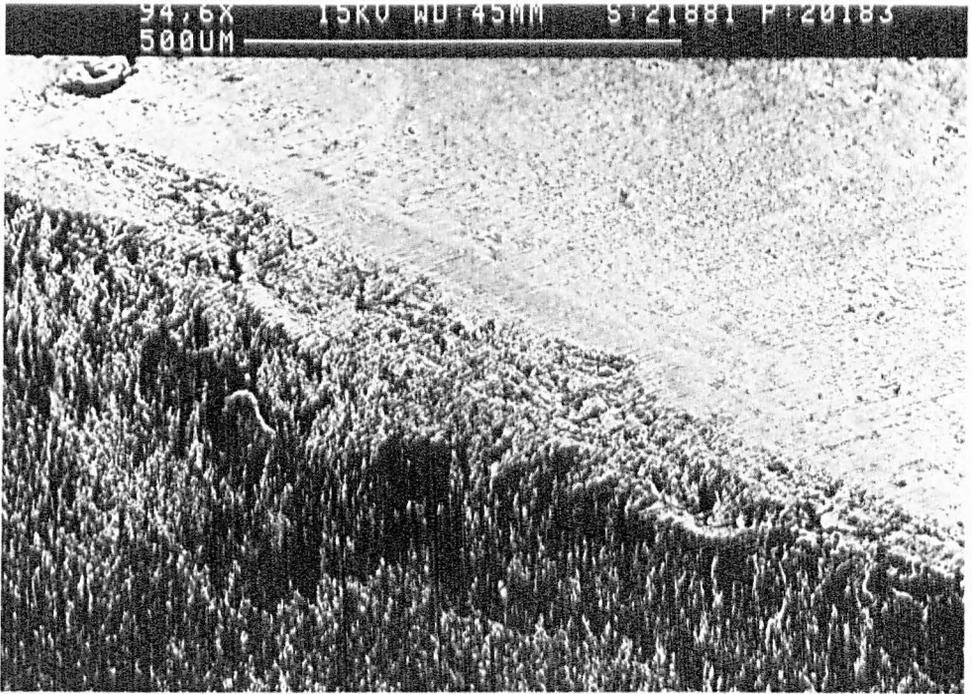
**Figure 6.18** Tool wear when machining Hardfacing B at 65 m/min (F0.25mm/rev, DOC0.65mm).

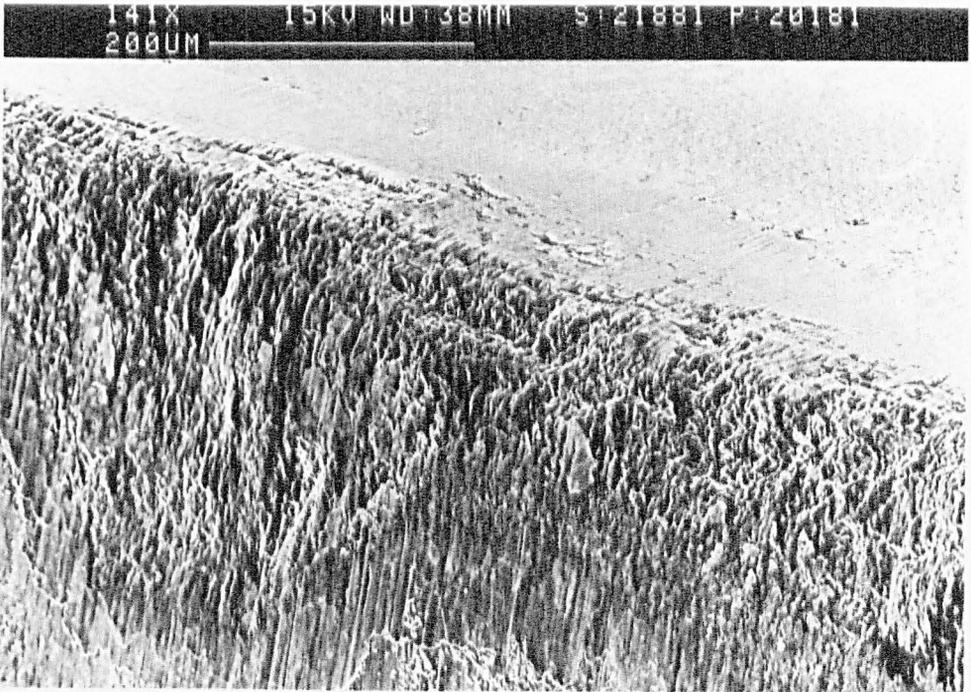
**Figure 6.19** Tool wear when machining Hardfacing B at higher speed (85m/min.) showing severe damage of the cutting edge and the flank of the tool (F0.25mm/rev, DOC0.65mm).

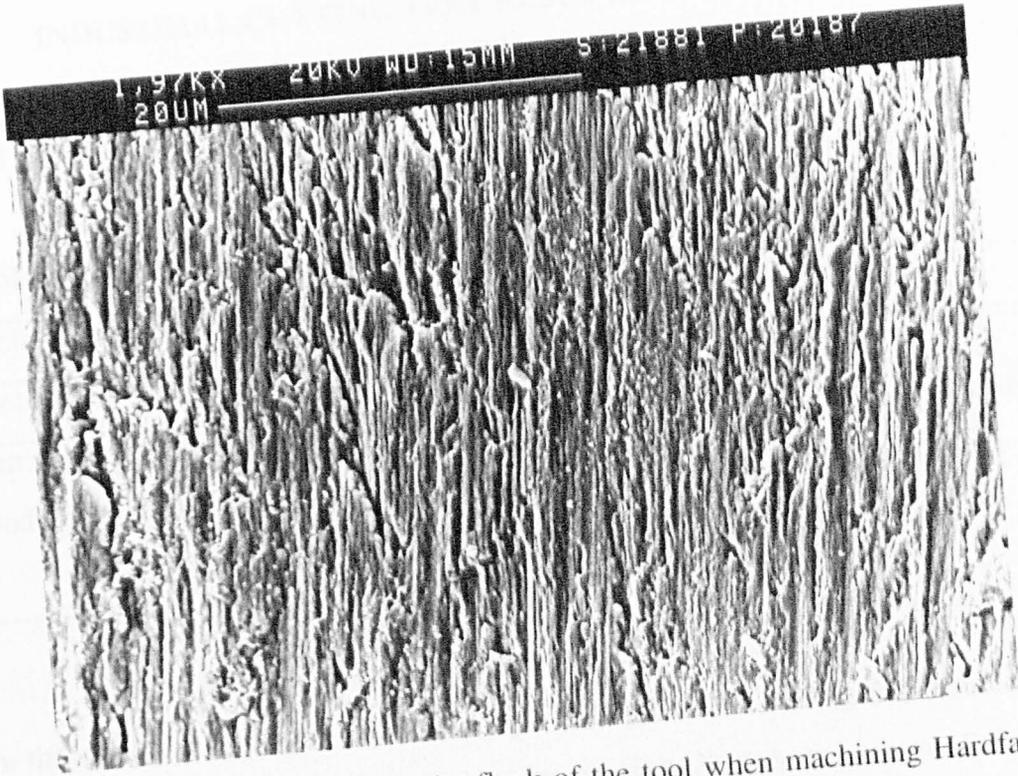
**Figure 6.20** Ridged surface on the flank of the tool when machining Hardfacing B showing abrasive wear process.

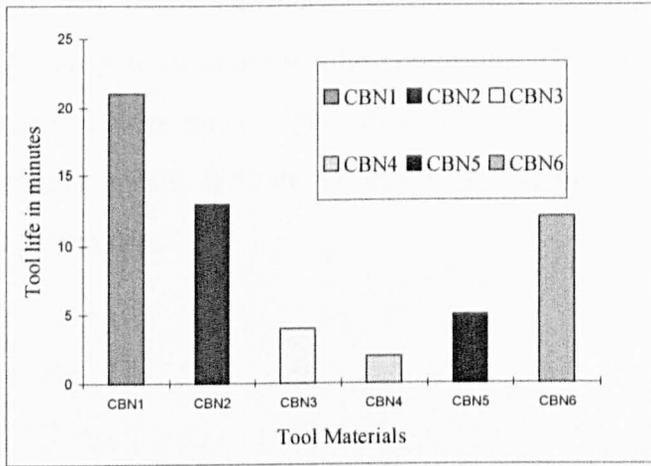
**Figure 6.21** Average cutting tool life of the CBN inserts.

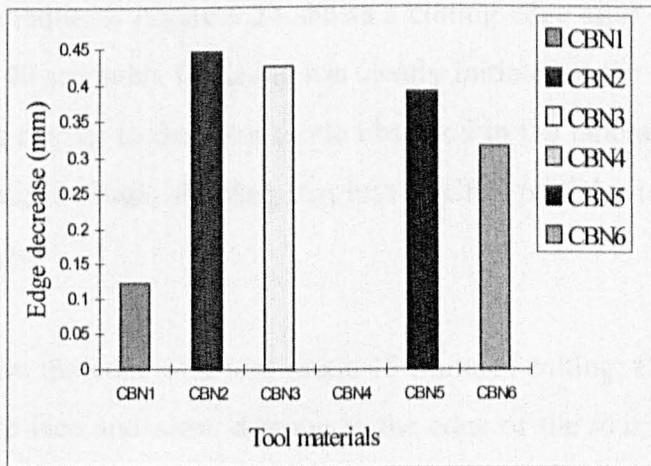
**Figure 6.22b** Decrease in the cutting edge of the PCBN tools.

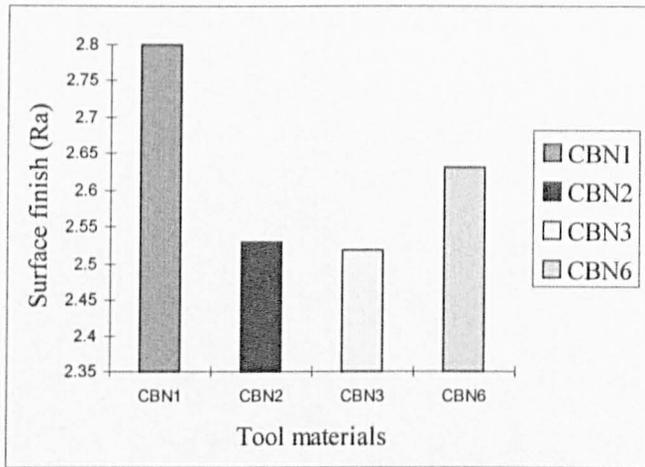
**Figure 6.23** Surface finish achieved by the PCBN tools.

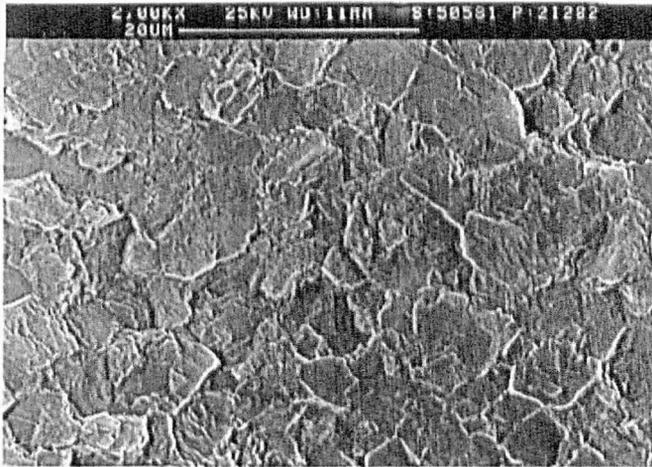
**Figure 6.25 b** Details of the flaking surface showing transgranular fracture.

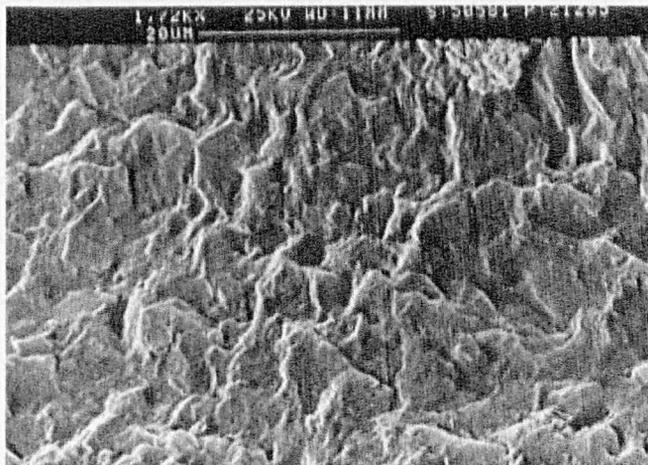
**Figure 6.25c** Close-up view of the near edge region of Figure 6.25a showing intergranular failure.

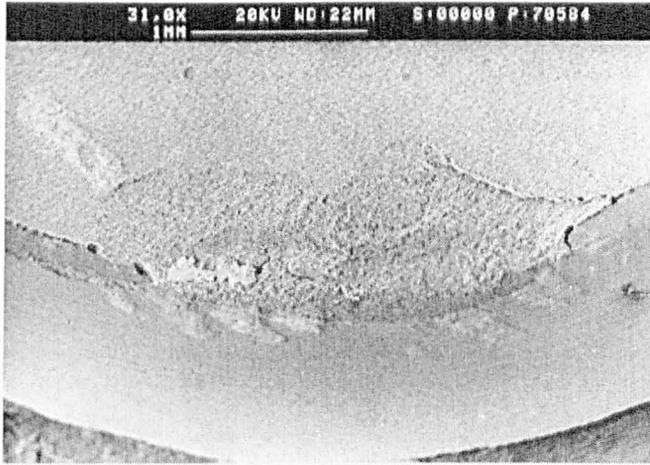
**Figure 6.26a** General view of CBN2 insert showing flaking of the rake face and adhered workpiece material.

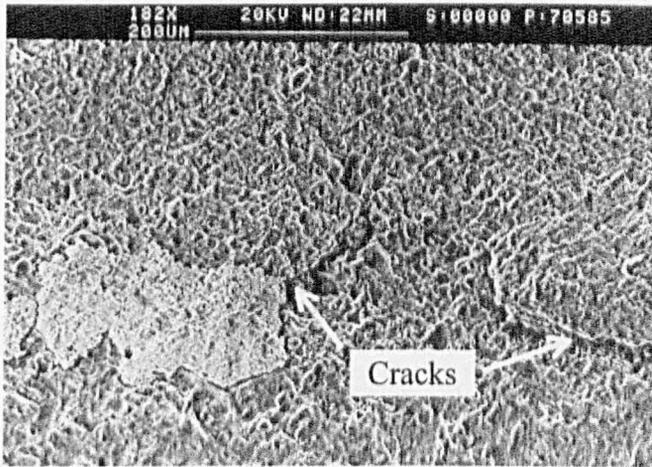
**Figure 6.26b** Close-up view of a) showing workpiece material adhering to the tool surface. The arrow indicates crack development into the tool material.

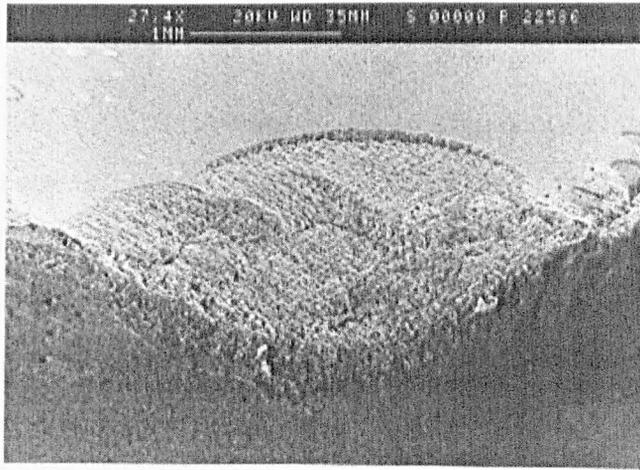
**Figure 6.27a** A typical cutting edge of a used CBN2 tool.

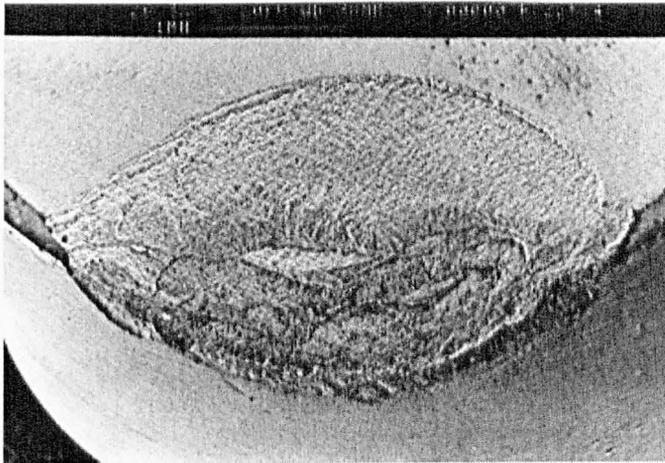
**Figure 6.28a** Failure mode of CBN3.

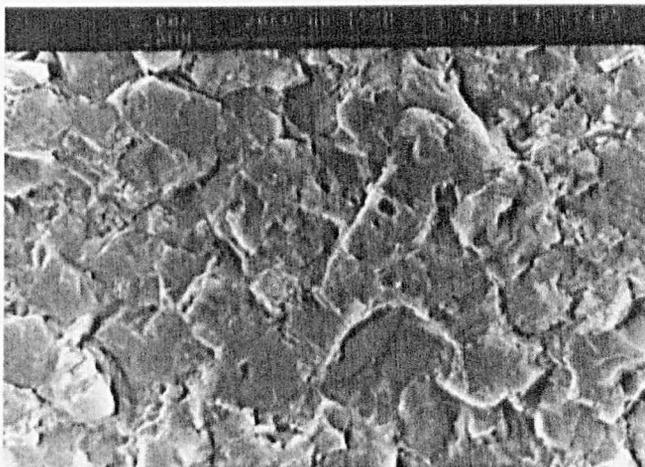
**Figure 6.28b** Detail of the flaked surface.

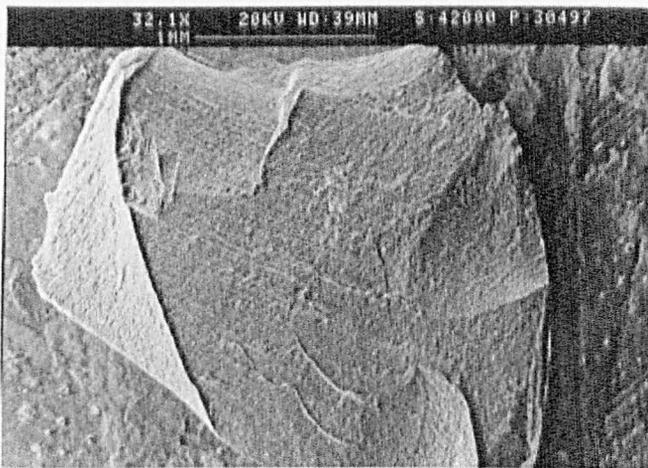
**Figure 6.29 b** Enlarged view of the fragment surface

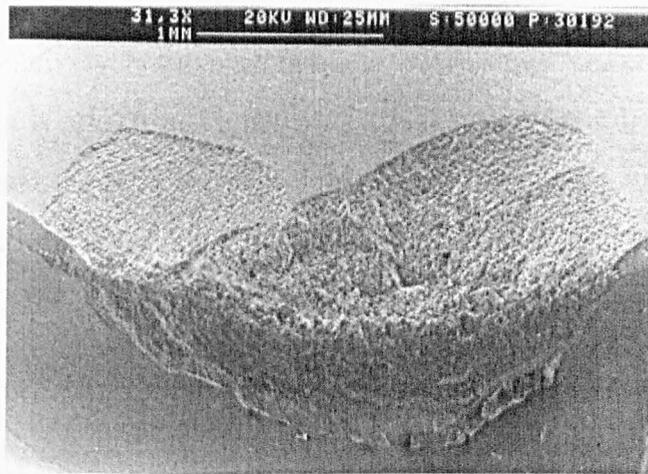
**Figure 6.30a** General view of a failed cutting edge of CBN5 showing flaking of the rake face and the delamination of the flank face

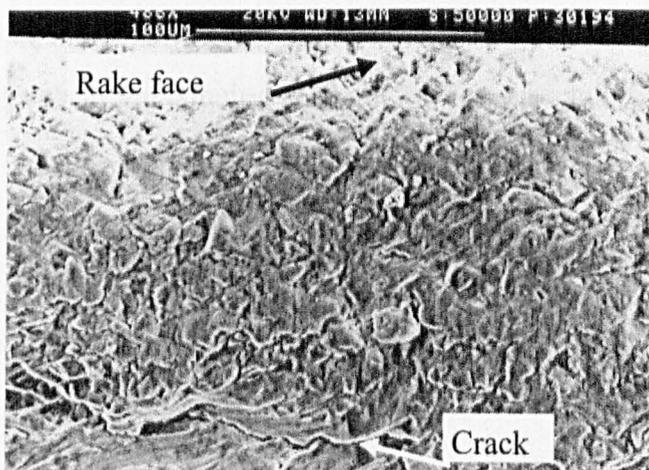
**Figure 6.30b** Detail of the delaminated surface and cracking of the cutting edge

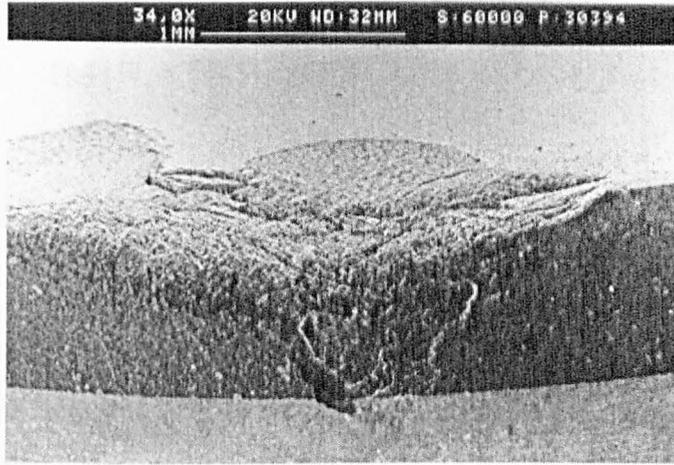
**Figure 6.31a** A general view of a failed cutting edge of CBN6 showing flaking of the rake face and the delamination fracture of the flank face extending down to the substrate.

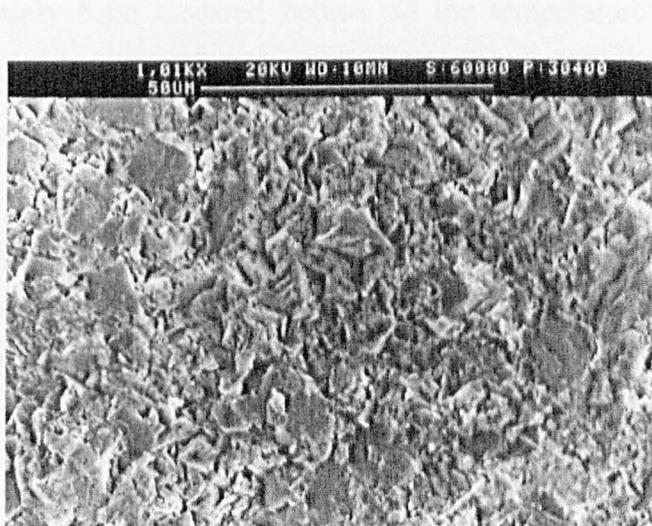
**Figure 6.31b** Detail of the flaked surface.

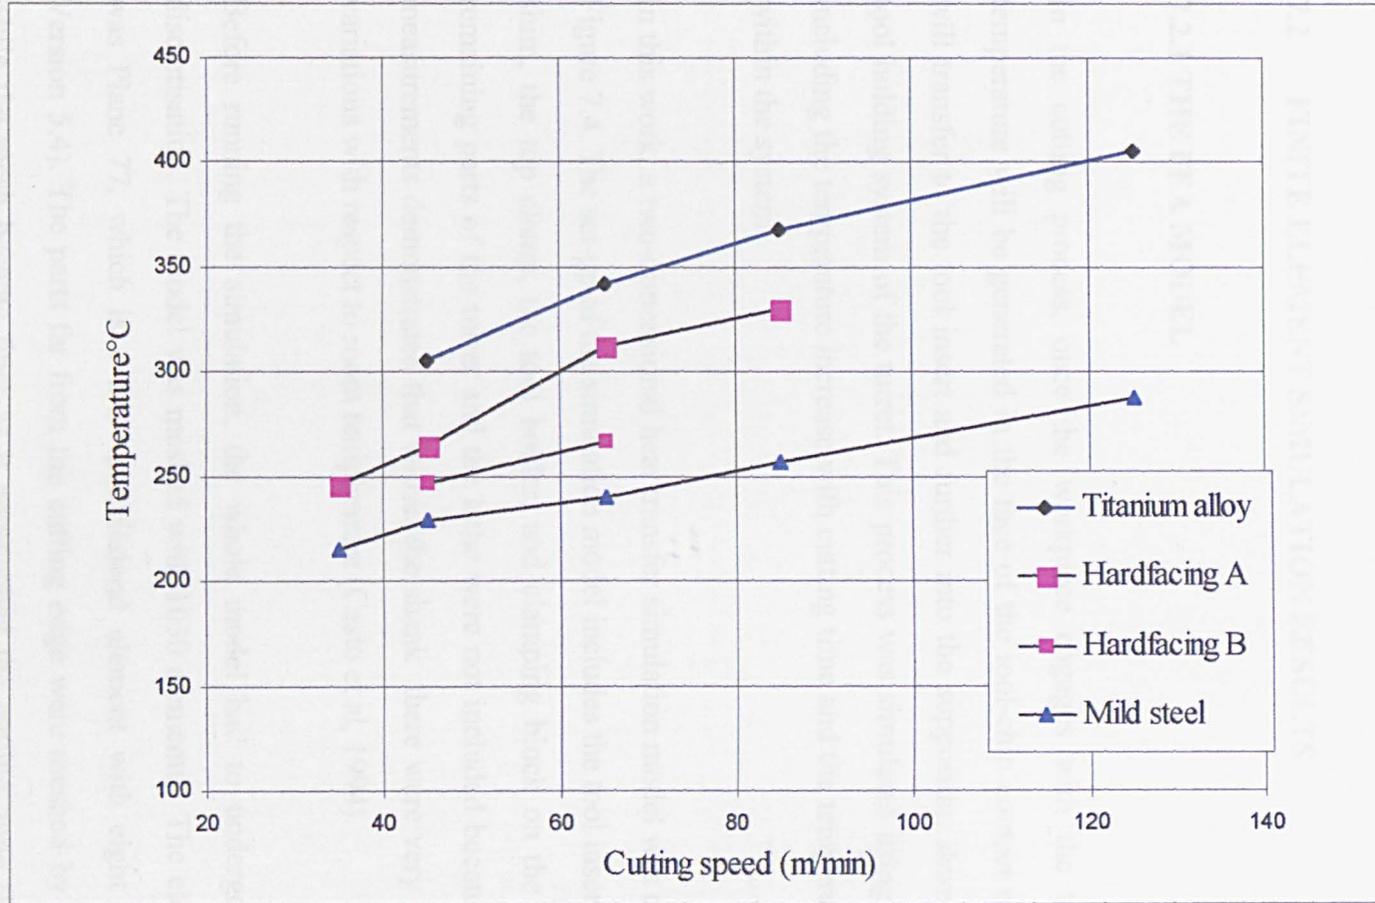
**Figure 7.2** Measured tool-shim interface temperature vs. cutting speeds (F0.25mm/rev, DOC0.65mm).

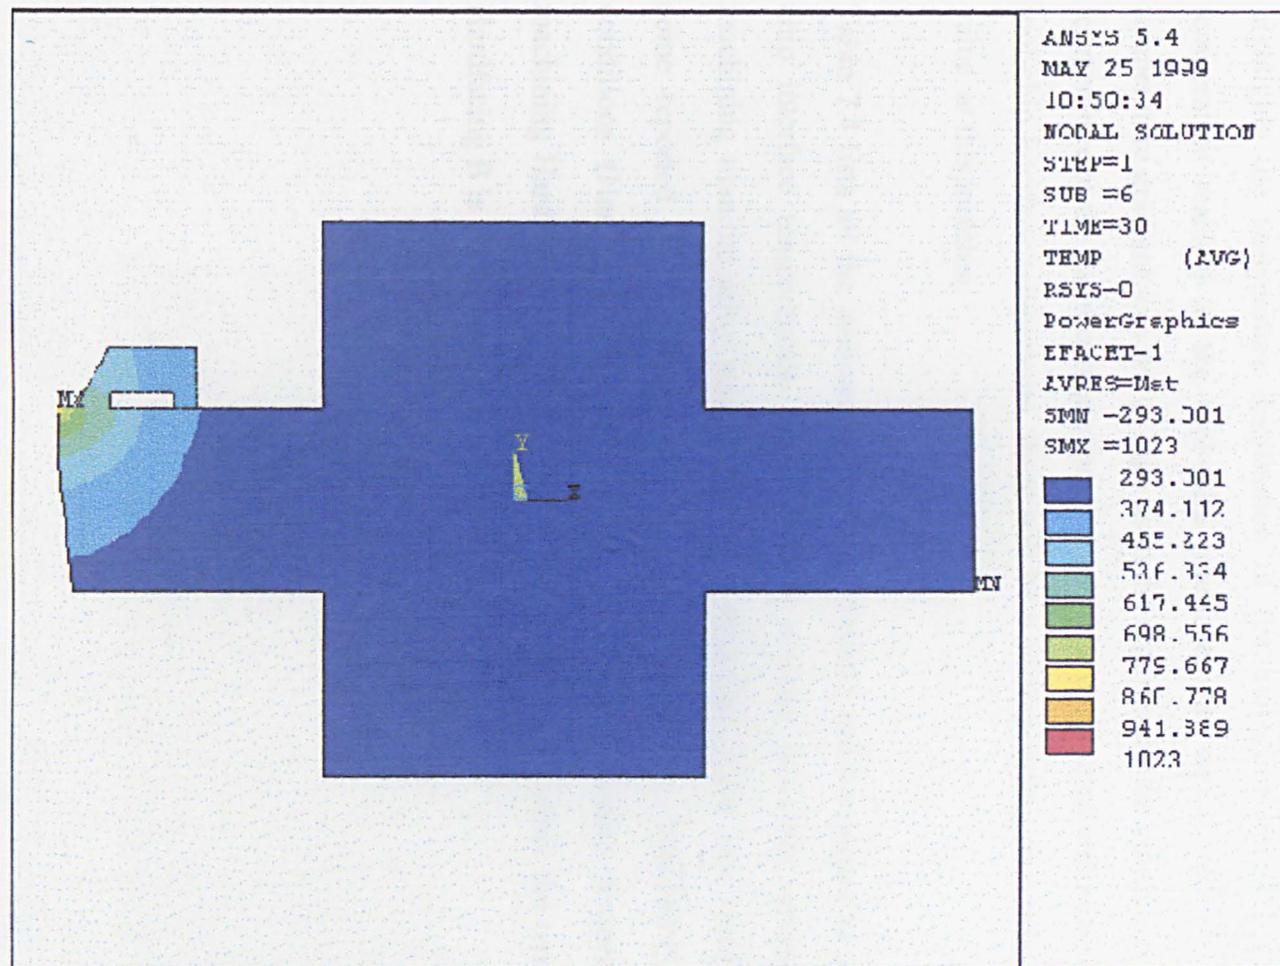
Figure 7.6 Temperature distribution of the system (K).

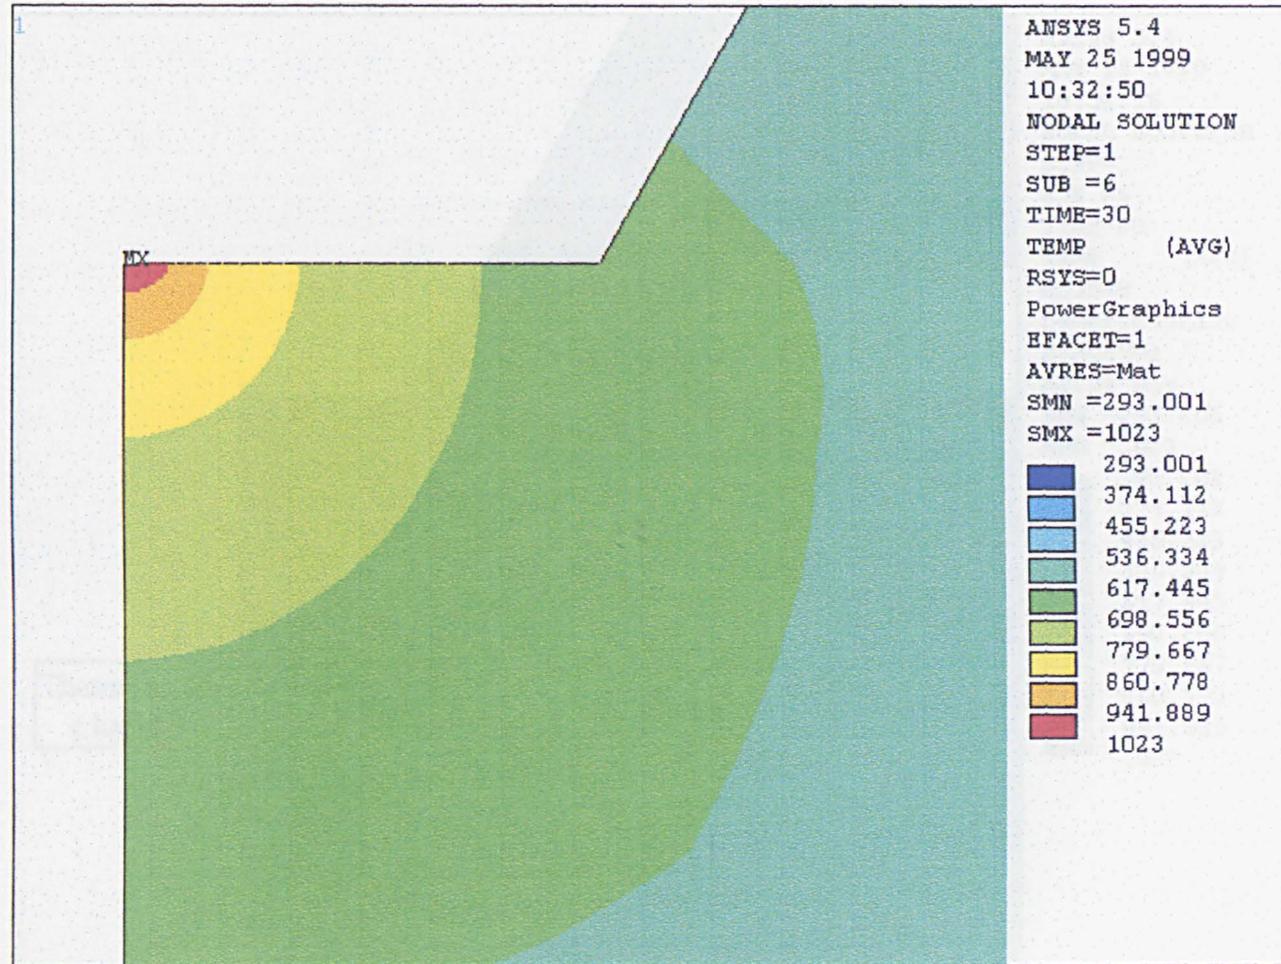
Figure 7.7 Temperature distribution of the cutting tool tip (K).

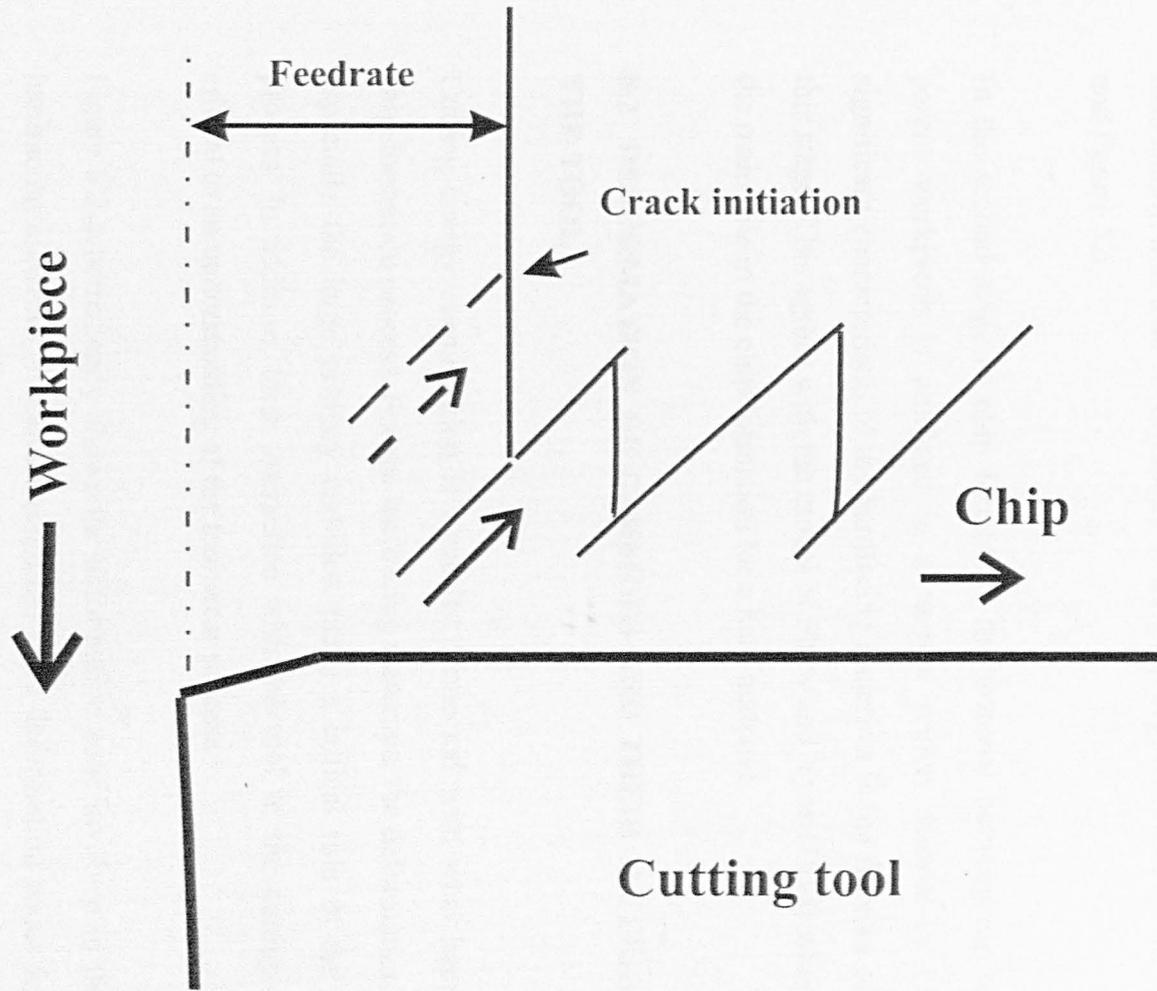
Figure 8.1 Schematic to show the mechanism of the chip formation process of the hardfacing materials

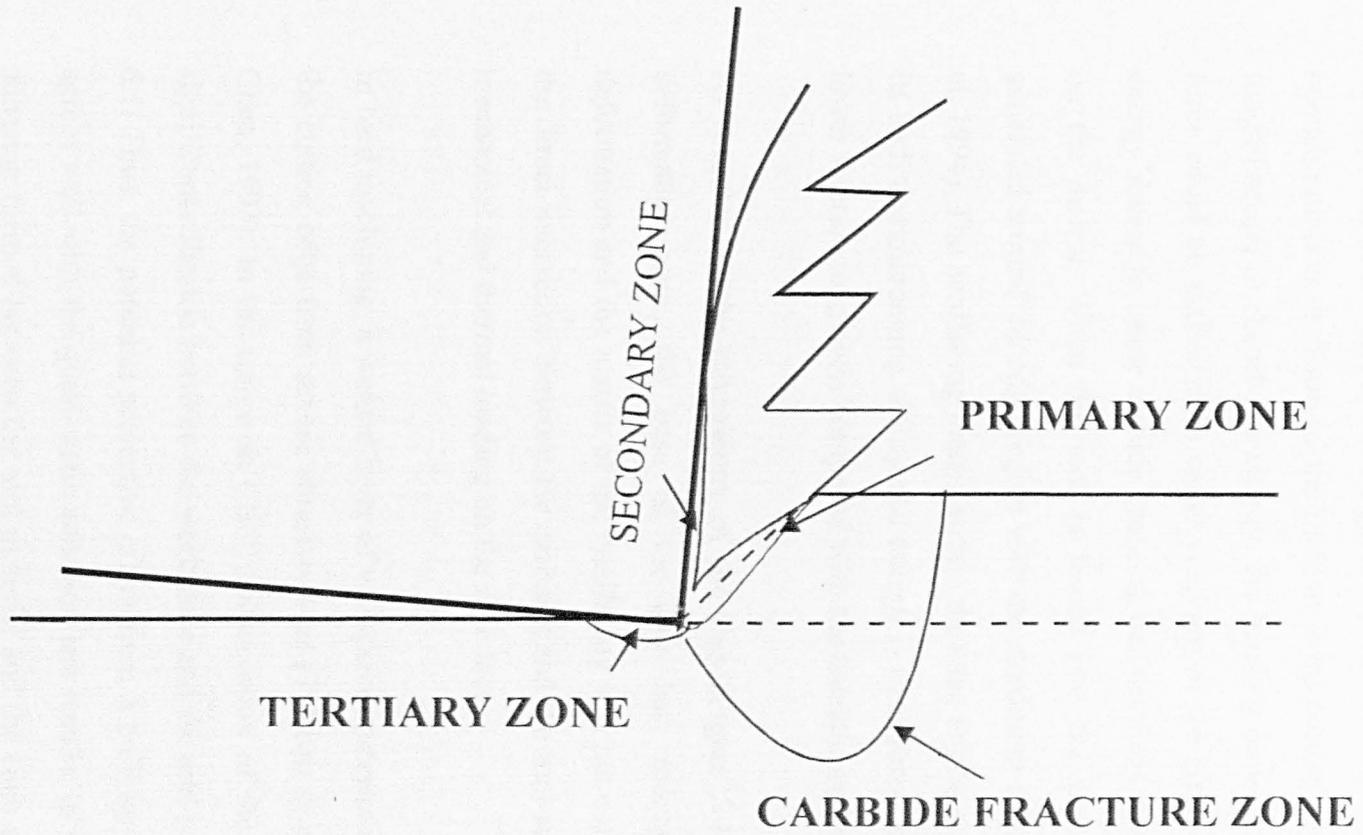
Figure 8.2 Deformation zone of the cutting process

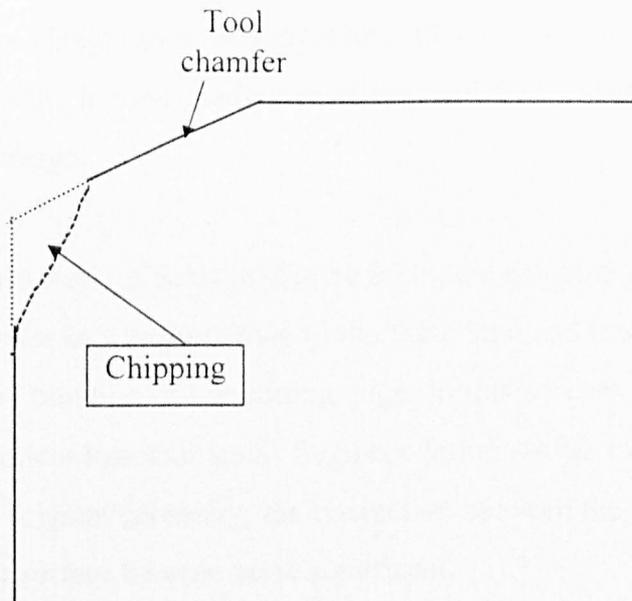
a) Earlier chipping of the lower edge of the chamfer

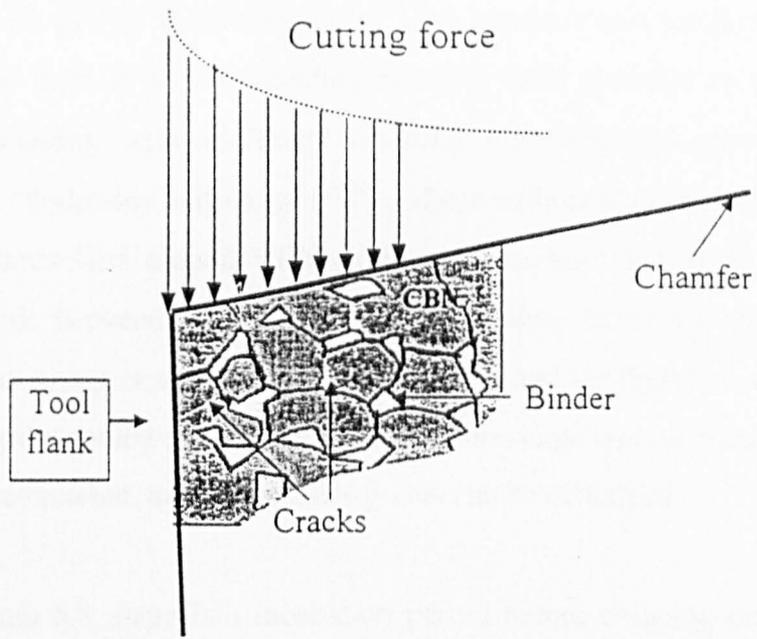
Figure 8.4 Schematic to show the chipping mechanism of the PCBN tool material.
